THE STREET, HACHESTON

**SURFACE WATER FLOOD RISK
TECHNICAL NOTE**

05th November 2025

5026555-RDG-XX-XX-RP-C-0502

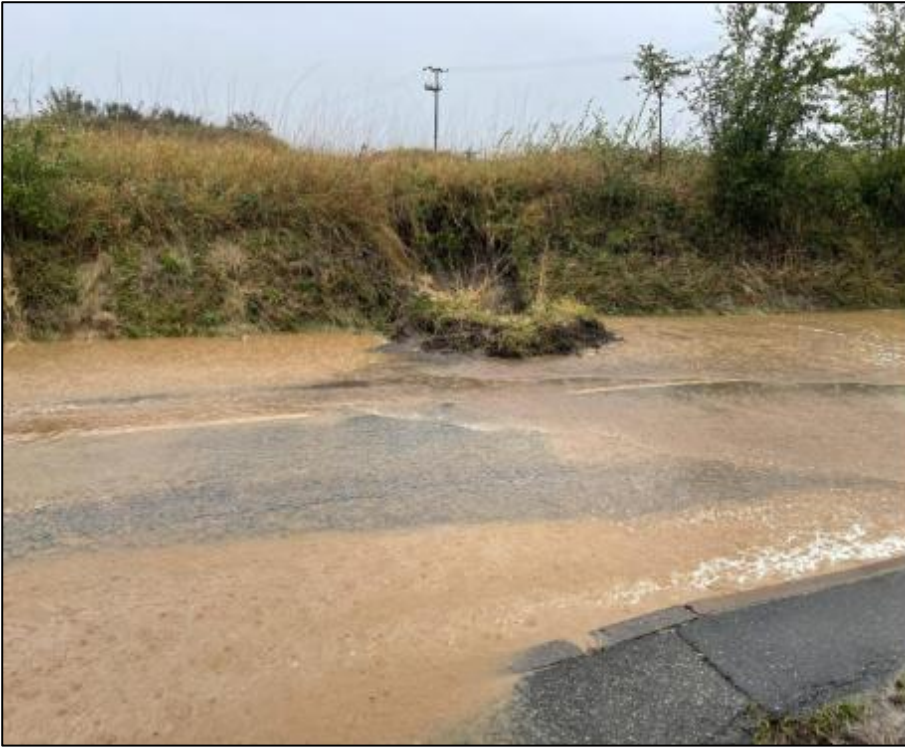
Photo 9: Bank on western side of 'The Street' opposite Thatched Cottage failure due to saturation.

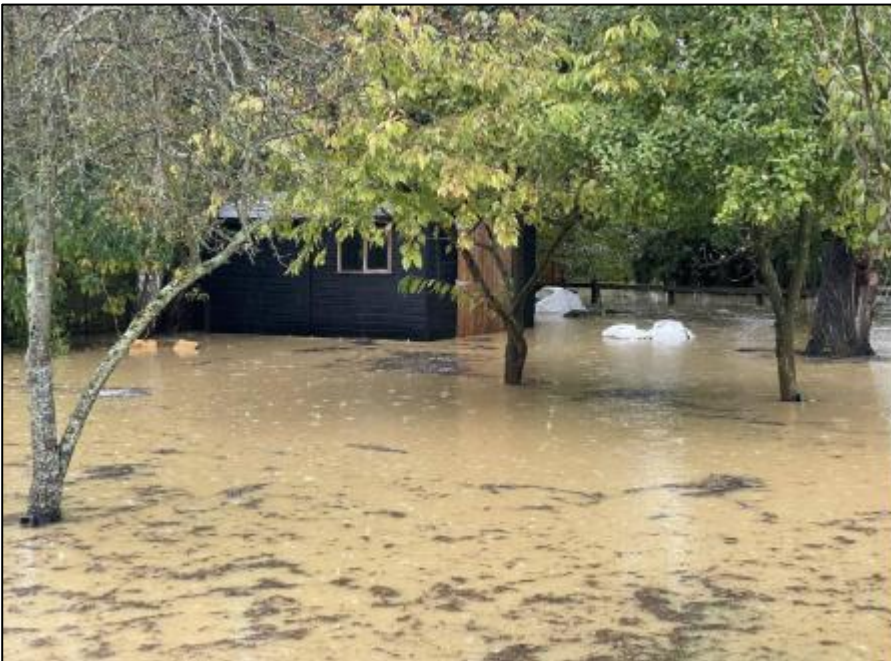
Photo 10: Flooding in rear garden at Thatched Cottage

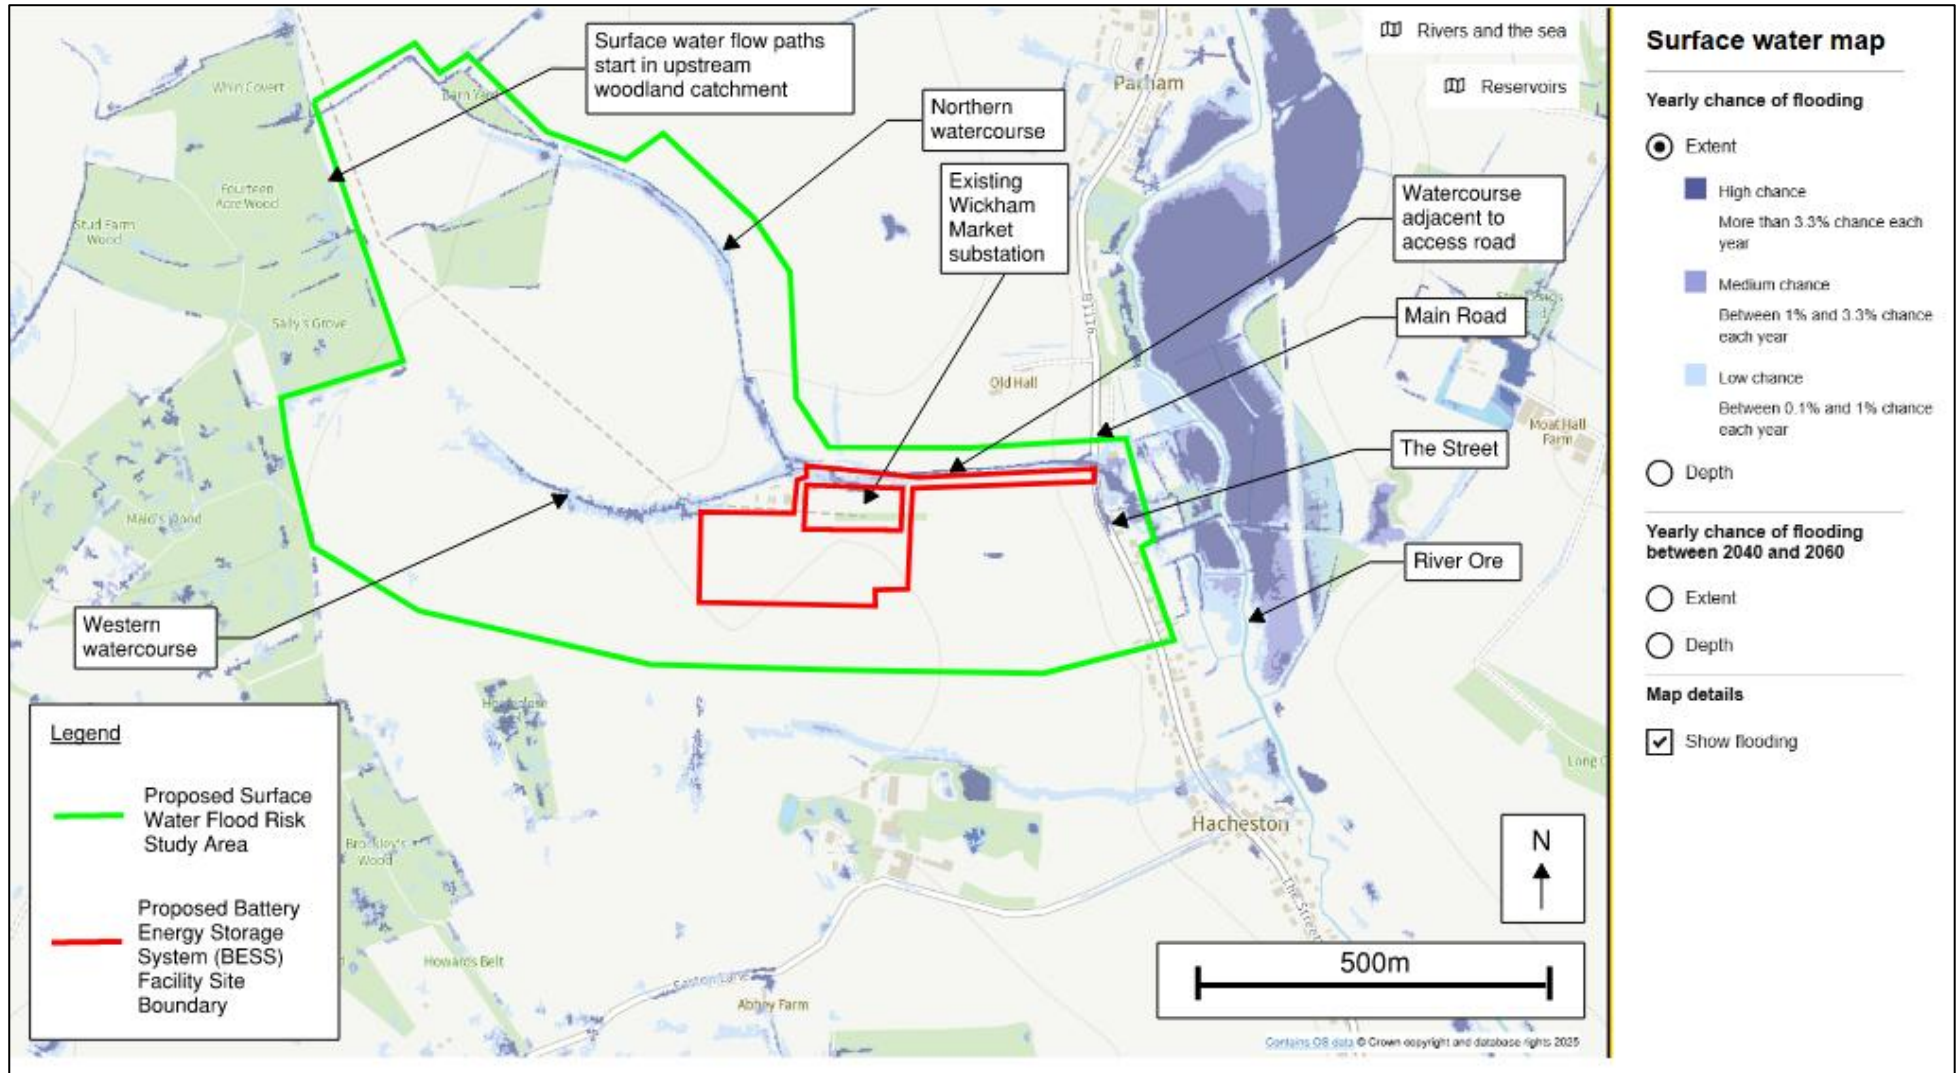
Figure 3 – Surface Water Flood Risk Mapping and Study Area

Based on the photographic evidence provided in the vicinity of Garnetts Gardens, and the surface water flooding along The Street close to this location, it appears that this surface water overland flow route, and the volumes of surface runoff being transported from the upper catchment, are a significant cause of the extensive surface water flooding in this location. An understanding of the surface water flooding mechanisms is important for identifying potential mitigation measures, which are discussed in Section 5 of this report.

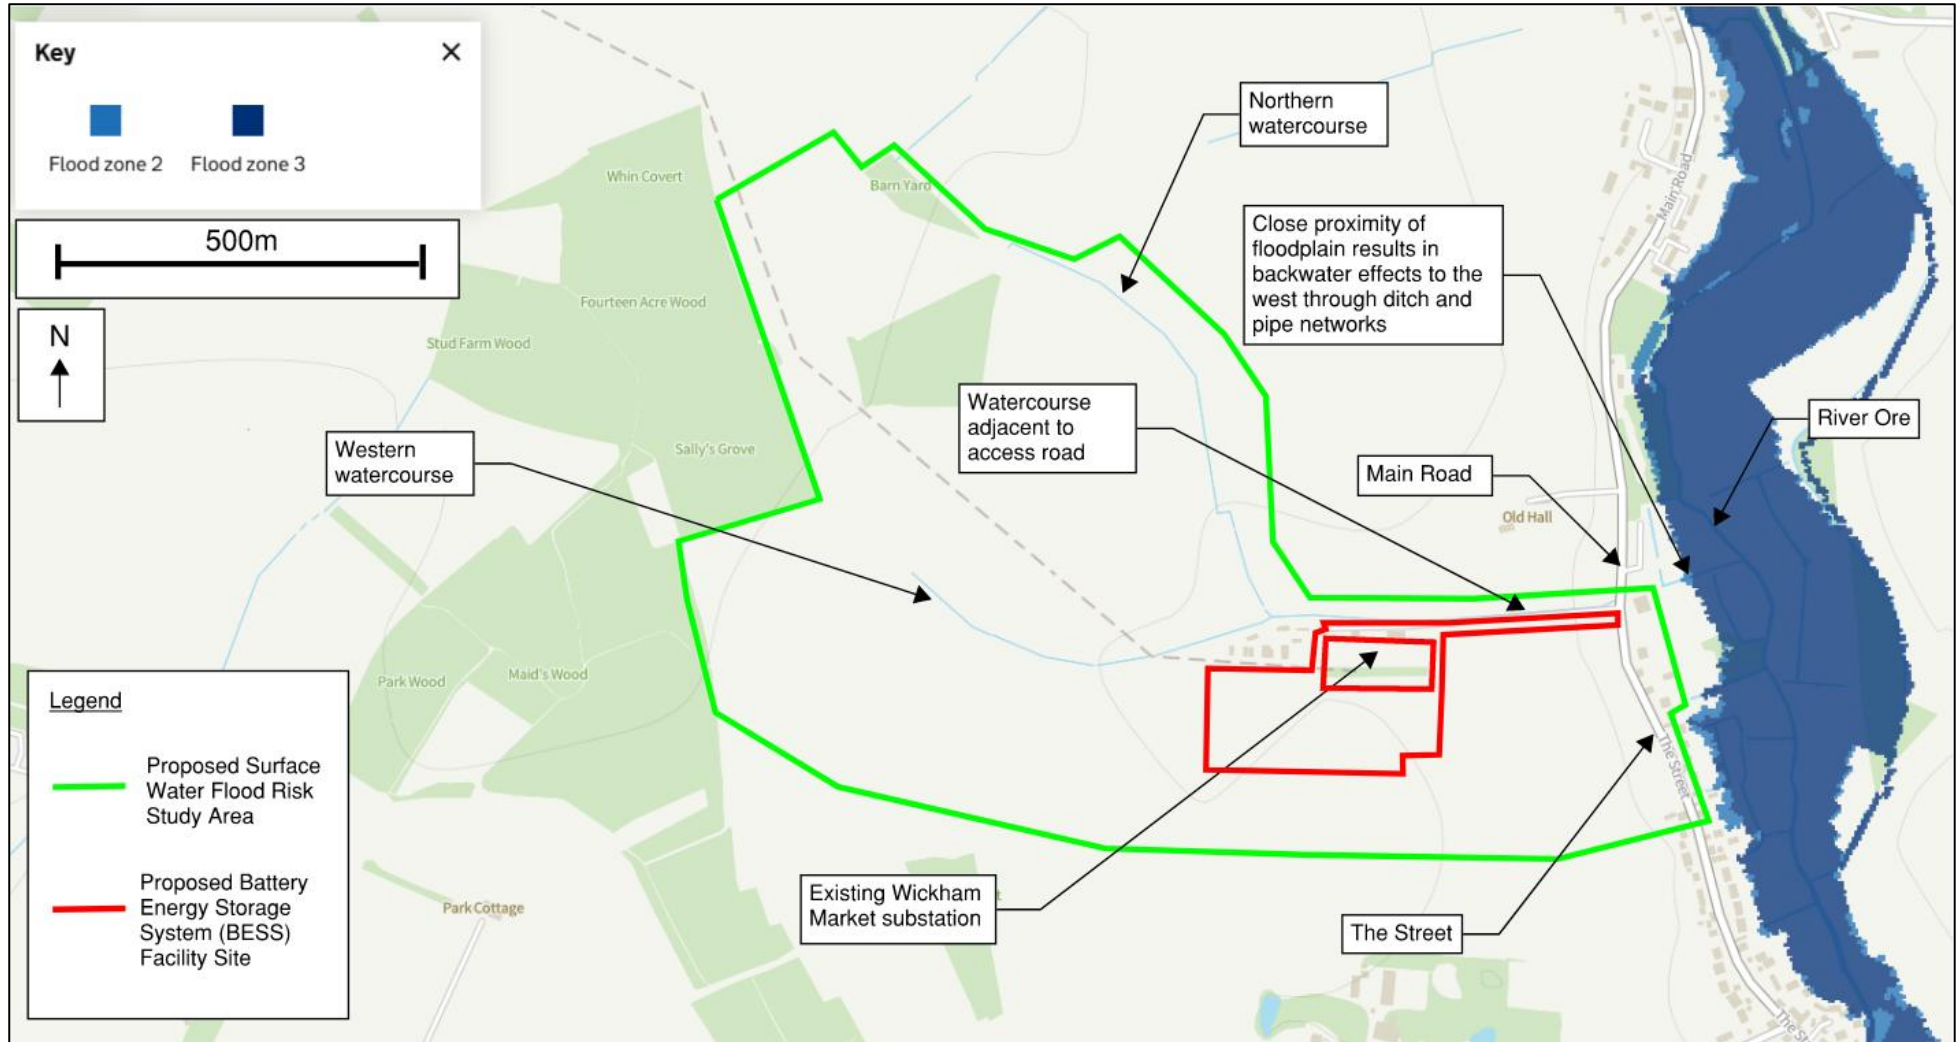
Figure 4 – Fluvial Flood Risk Mapping and Study Area

The fluvial (river) flood risk mapping illustrated in Figure 4 indicates that the floodplain associated with the River Ore extends across the rear gardens of properties along The Street. Whilst internal property flooding from the River Ore may not have previously occurred, it has been reported by residents in the 'Local Evidence Collection' note that the elevated water levels observed in the River Ore, and ditches connected to the floodplain, had limited/ no capacity to receive the vast amount of surface water from the western agricultural catchment. It is likely that the elevated river levels were a contributing factor in how efficiently the highway was able to drain, exacerbating the flooding and standing water around the highway culvert (opposite Garnetts Gardens) and gullies along The Street (noting that blockages from silt and debris were also reported as clogging the storm drainage systems).

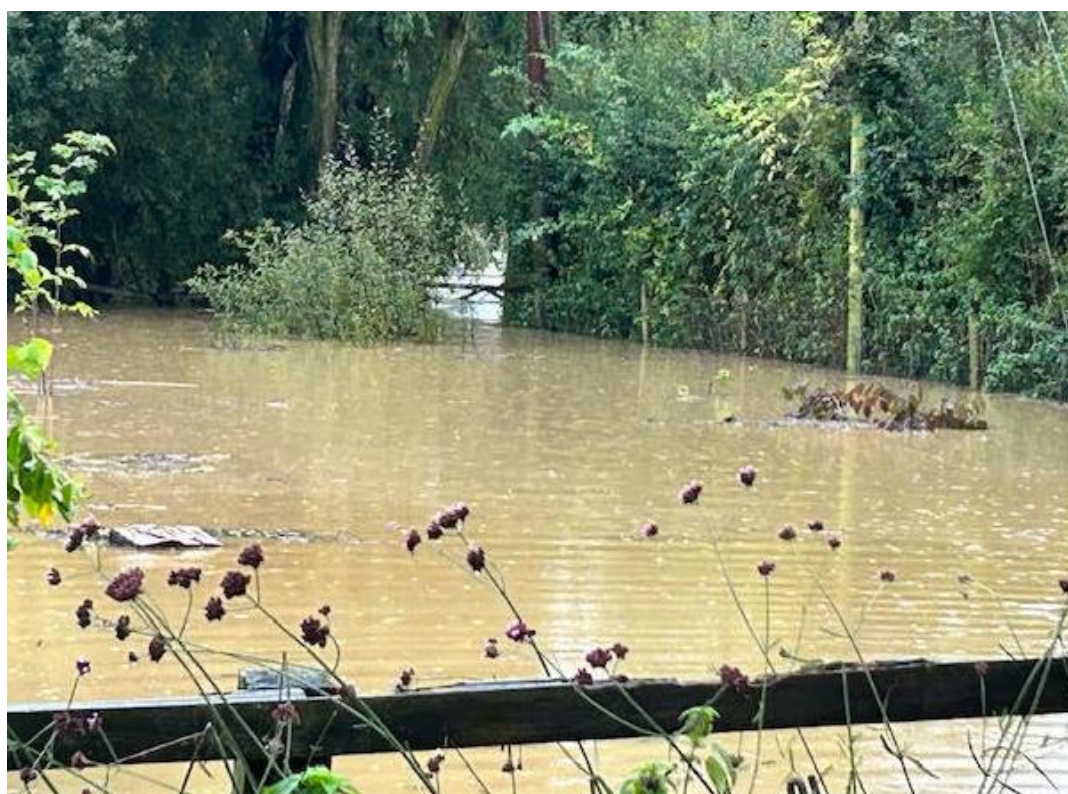
The Fen – Surface water ran from field opposite onto road and wake from traffic cause further flooding into property

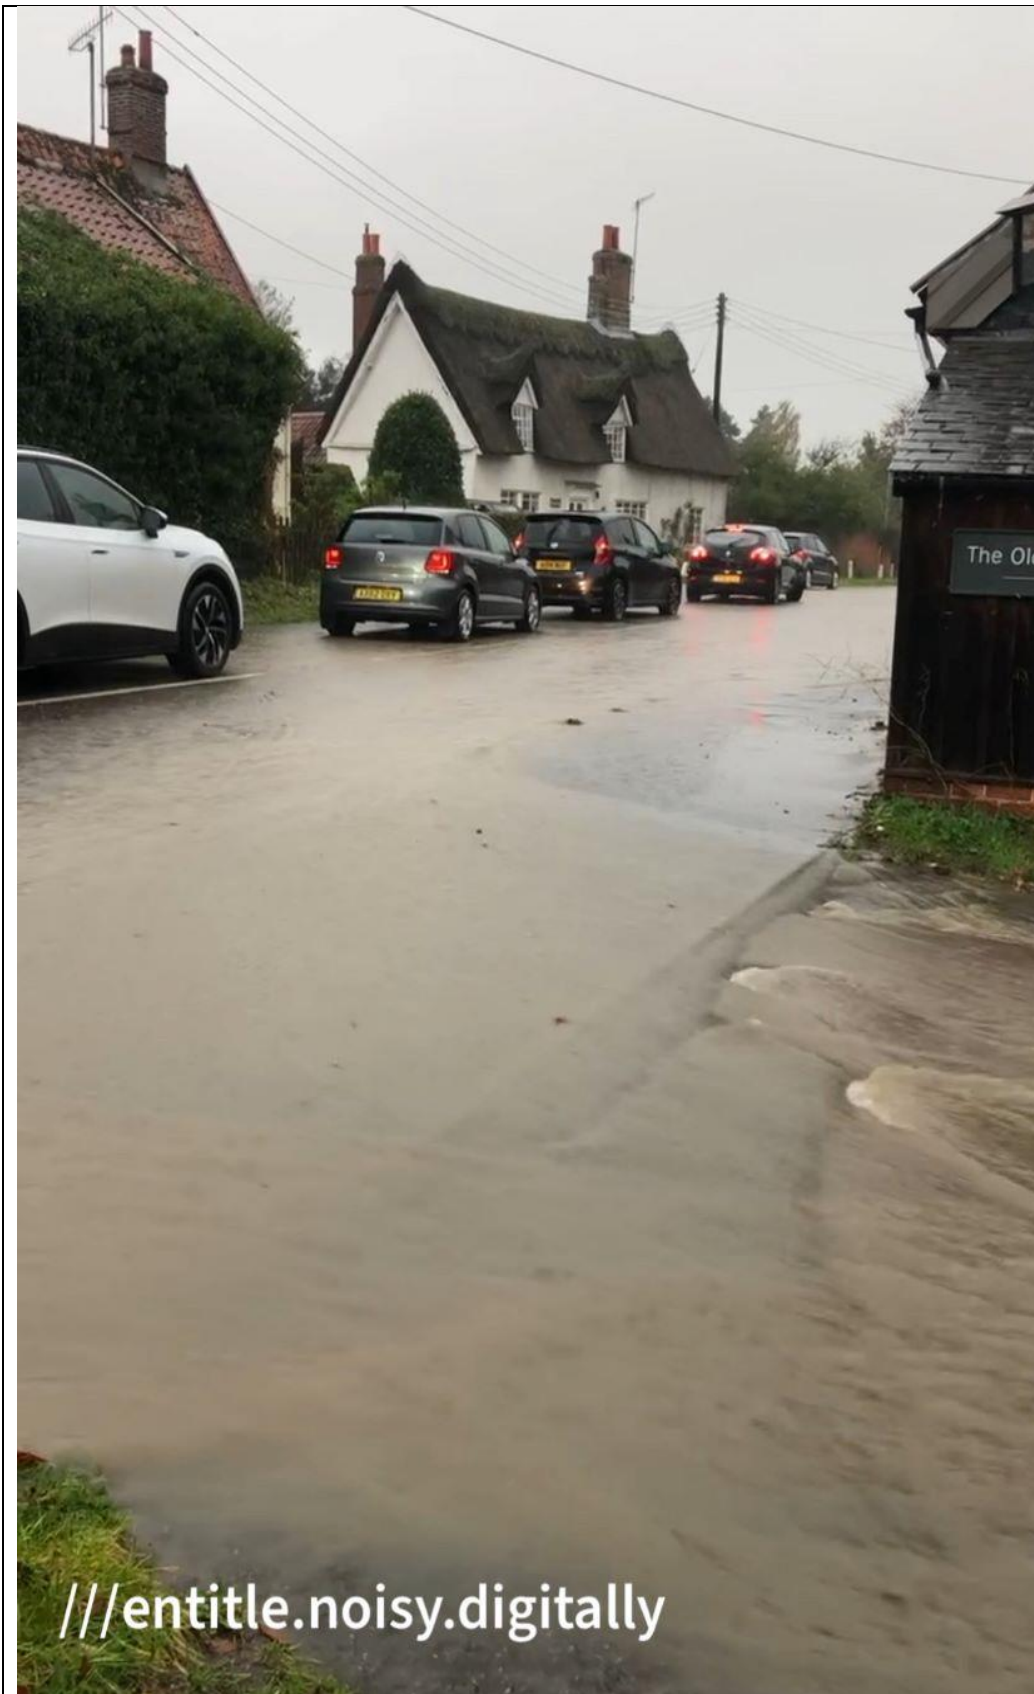
Photo taken facing North West. Water pouring off road down lane between Apple Tree Cottage and The Old Forge ditches were overwhelmed

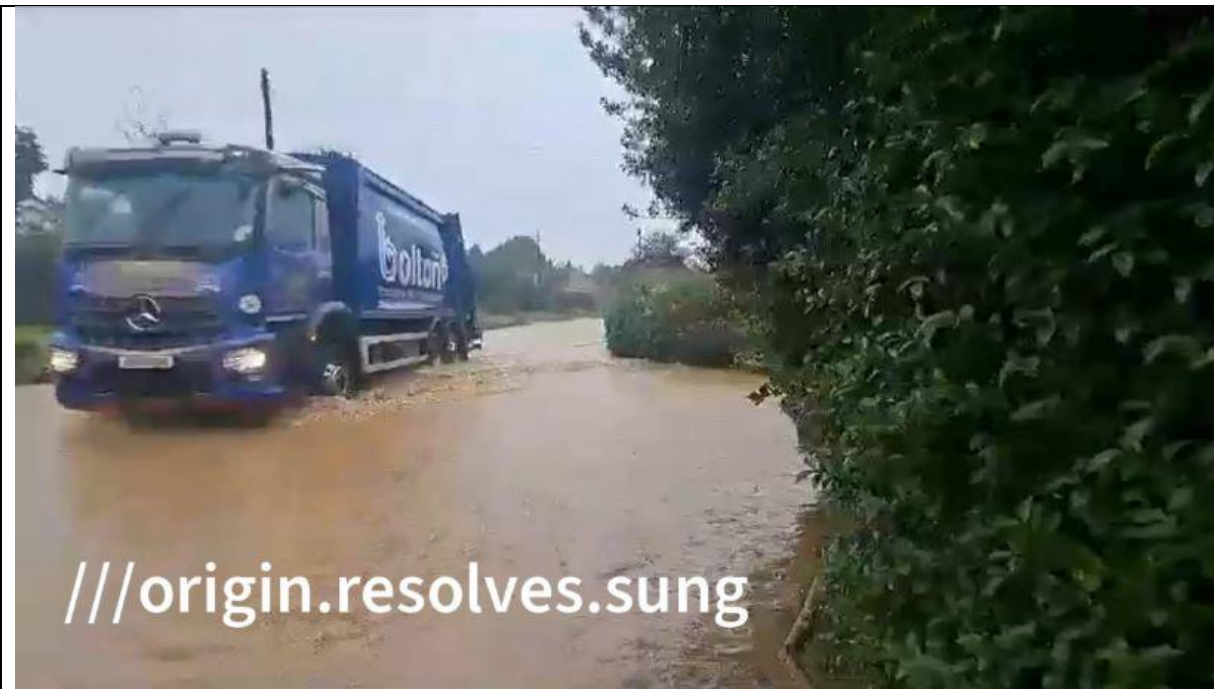
Photo taken facing North showing wash from vehicles pushing water into properties

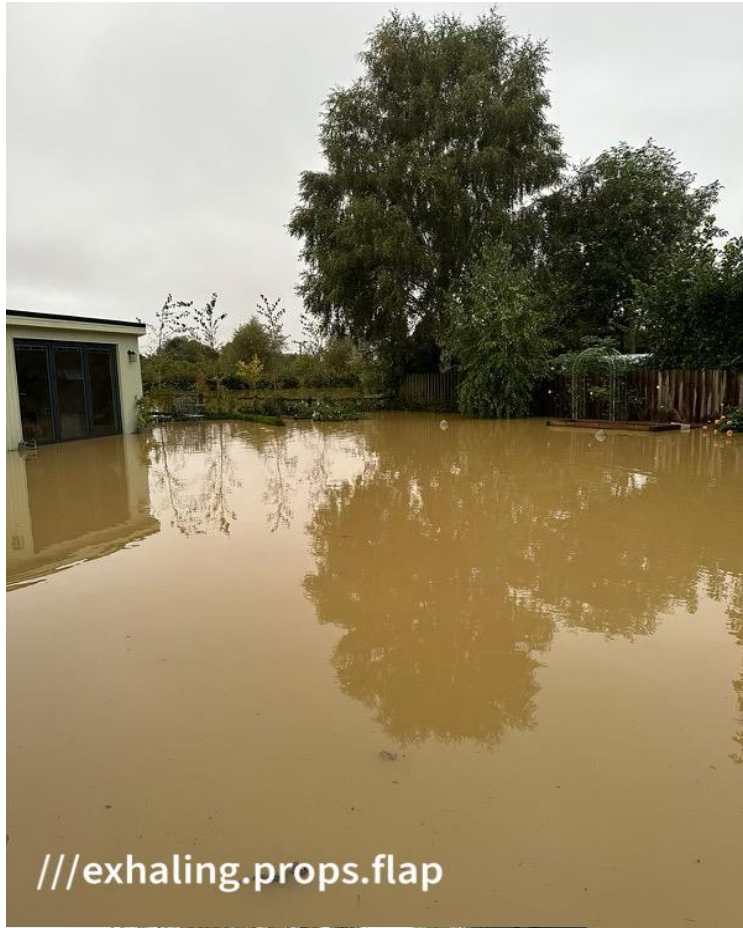
Photo taken facing North water levels were up to 700mm deep here at 6pm

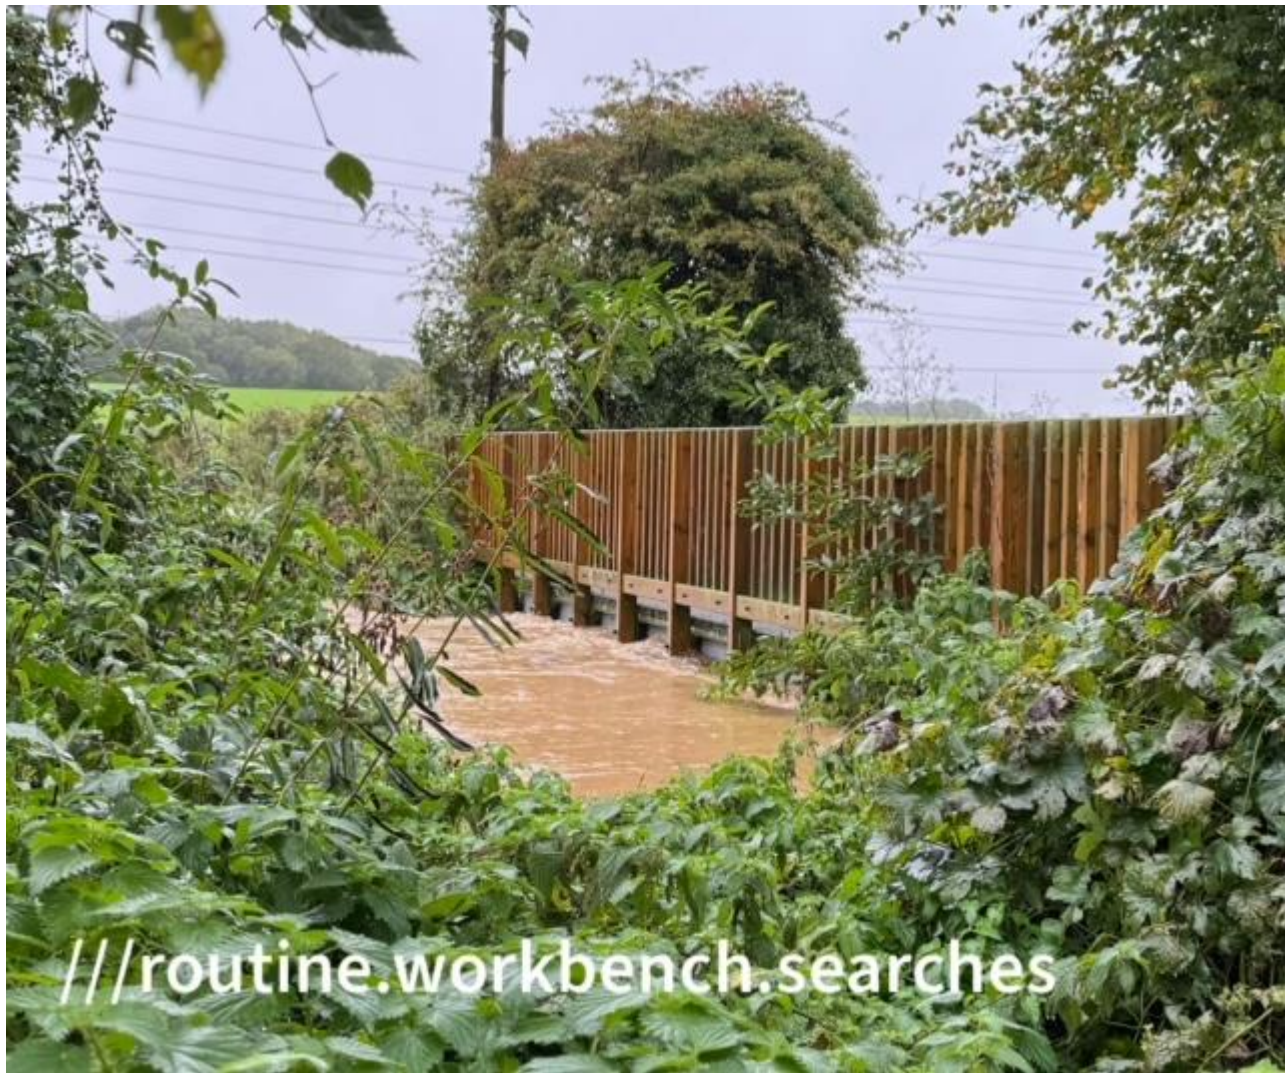
This photo shows water levels at about 4pm. This bridge was installed during 2020 flood waters were restricted by the deep steel beams used to support it. Water levels rose another 100mm after this photo. The height of the water flow on the south side of the bridge was 300mm lower.

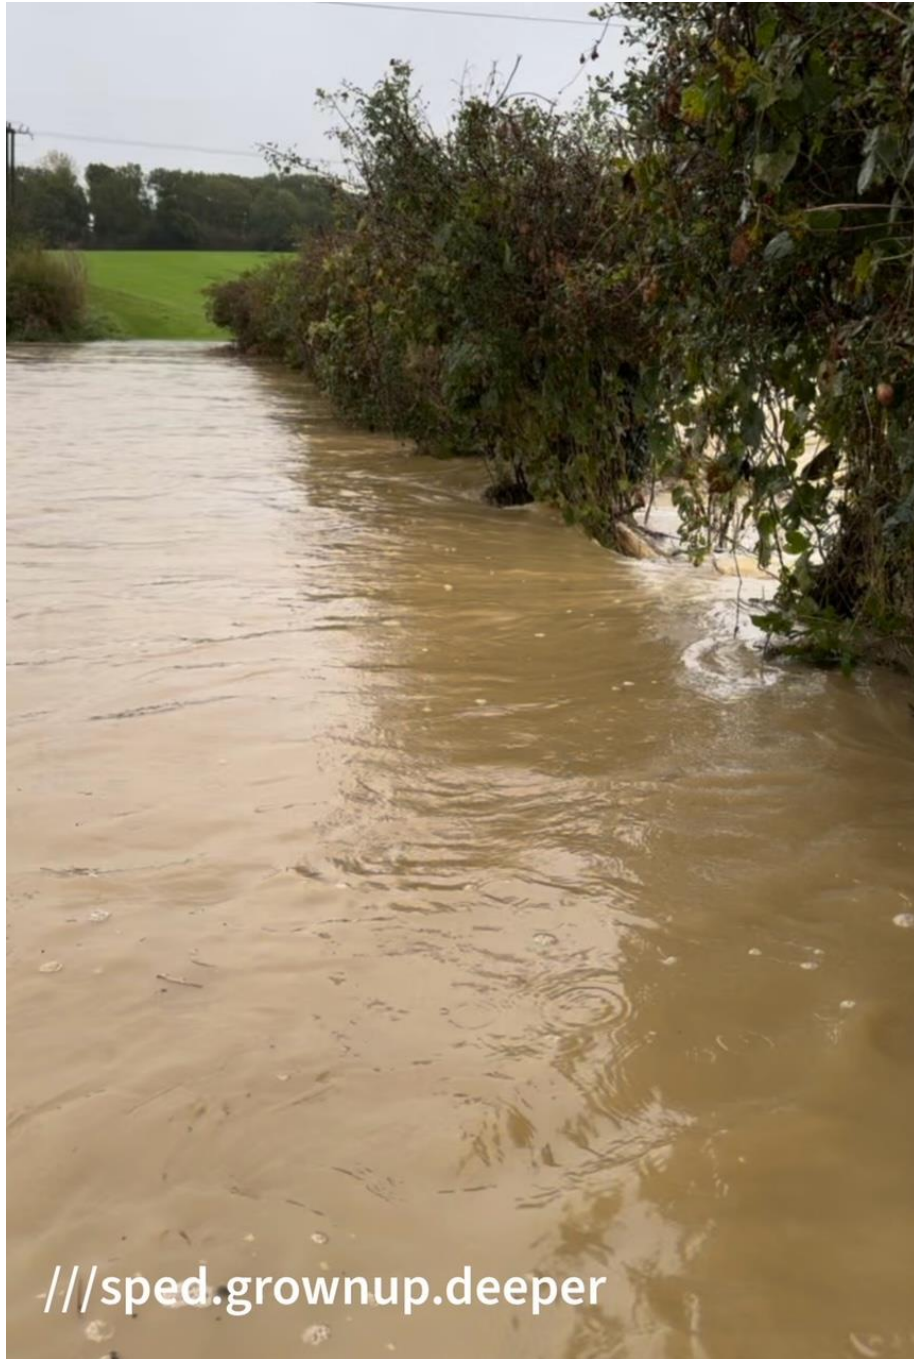
Photo taken facing East from the other side of the bridge at 4pm

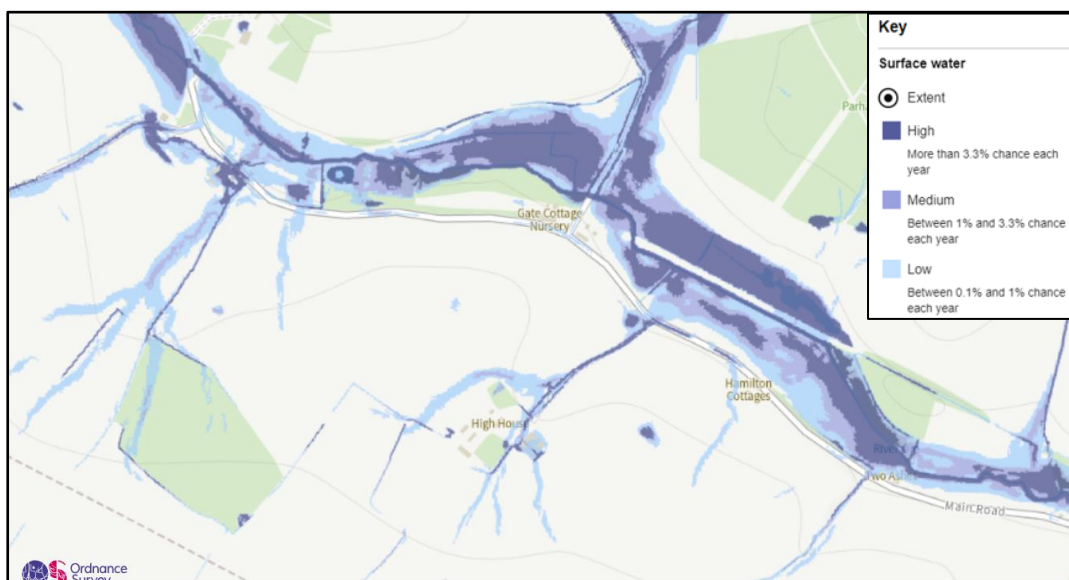
Figure 11. Surface Water flood risk on Main Road northwest of Parham

Northwest of Parham, on Main Road, following heavy rainfall on the morning of the 20 October, internal flooding to property was caused by large amounts of surface water coming across the fields combined with overwhelmed drainage ditches. Internal flooding was reported from 10am onwards. Residents stated drainage ditches were overwhelmed by the volume of water and required maintenance. North of Main Road, the river Ore overtopped its banks and added to the spread of floodwater.

- Heavy rainfall on the morning of the 20 October caused large amounts of surface water to flow across the fields and drainage ditches towards properties of Main Road.
- The flooding may have been exacerbated by a lack of ditch maintenance.
- Sections of Main Road are shown to be at Medium to High risk of surface water flooding on the national predicted flood risk mapping.

- Residents to install Property Flood Resilience (PFR) via grant funded scheme.
- Investigate potential NFM projects to 'slow the flow' and attenuate water on overland flow paths (leaky dams, restoration of watercourses, etc.) south of Main Road northwest of Parham.
- Landowners to carry out appropriate watercourse maintenance to reduce flood risk as necessary as per their riparian responsibilities.

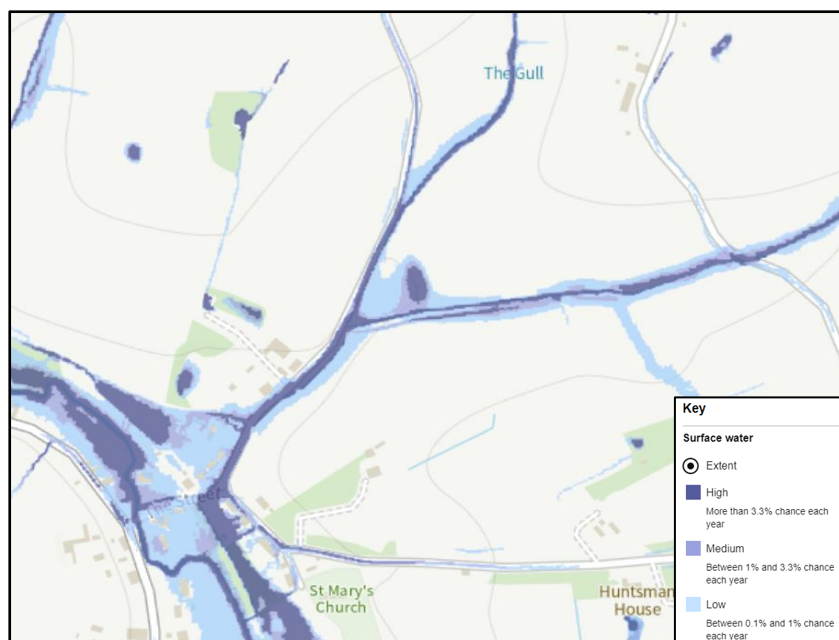
Figure 14. Surface Water flood risk on The Street, Brick Lane and North Green Road

reports of gullies bubbling up and surcharging as the system could not cope with the volume of water coming into it.

The observed extents of the floodwater in this area correlates closely with the predicted surface water flood risk maps, with pluvial flood risk categorised as being high along sections of The Street, Brick Lane and North Green Road.

Properties on North Green Road were impacted from flood water from the road and river Ore but also from the rear. It is reported that surface water flowed off the fields to the north, under the redundant railway line, into an ordinary watercourse. It was noted that the watercourse has historically been partially infilled and during the event, flood water flowed overland into property.

- Investigate potential NFM projects to ‘slow the flow’ and attenuate water on overland flow paths (leaky dams, restoration of watercourses, etc.) northeast and east of Parham.
- Investigate realignment of the old watercourse behind properties on north green road to reinstate connection with the river Ore.
- Silt buildup immediately downstream of the road bridge on north green road to be removed by SCC Highways.
- Report any observed blockages below the road bridge on north green road on the Suffolk Highways Online Reporting Tool.
- Landowners to carry out any watercourse / culvert maintenance to reduce flood risk as necessary as per their riparian responsibilities.
- Ensure the completion of highway drainage asset cyclic maintenance on North Green Road and The Street.

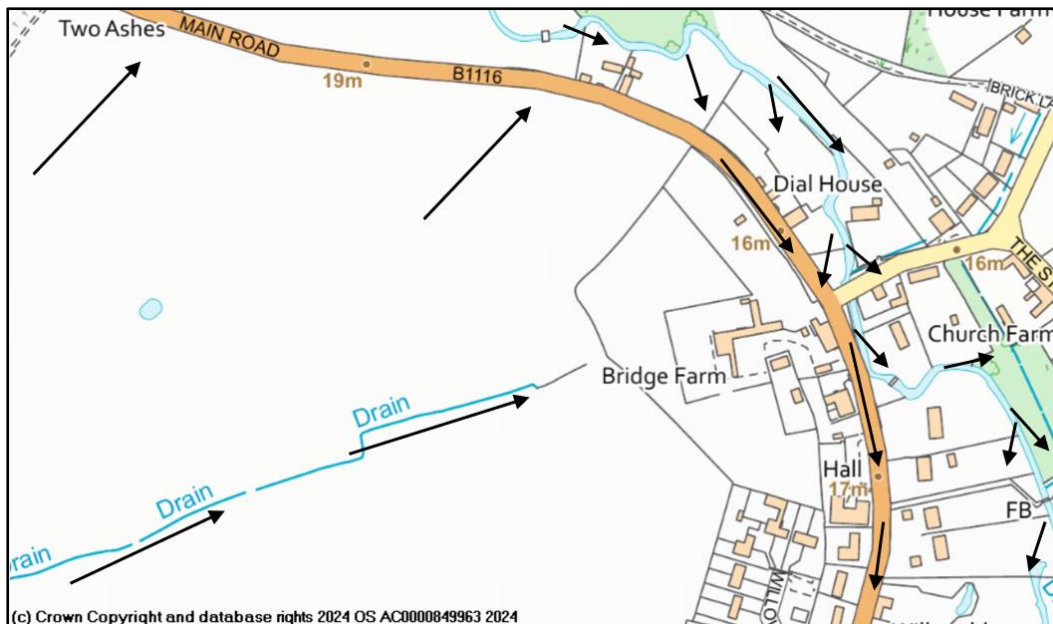
Figure 15. Approximate floodwater flow routes on Main Road, central Parham

The primary source of flooding in Parham was fluvial, with the Main Road being significantly impacted when flood water overtopped the banks of the river Ore. There was also surface water runoff from the east and west, caused flooding to multiple properties from the front and rear along Main Road (see Figure 15).

The overtopping of the watercourse occurred slightly north of the village and continued to breach the riverbank as it flowed through Parham. Flood water was on the highway and effectively created a second flow path along the road towards Hacheston and extended along the lower end of North Green Road toward The Street (see Image 2).

- Residents to install Property Flood Resilience (PFR) via grant funded scheme.
- Investigate potential NFM projects to 'slow the flow' and attenuate water on overland flow paths (leaky dams, restoration of watercourses, etc.) northeast and east of Parham.
- Landowners to carry out any watercourse / culvert maintenance to reduce flood risk as necessary as per their riparian responsibilities.
- Ensure the completion of highway drainage asset cyclic maintenance on Main Road, Parham.

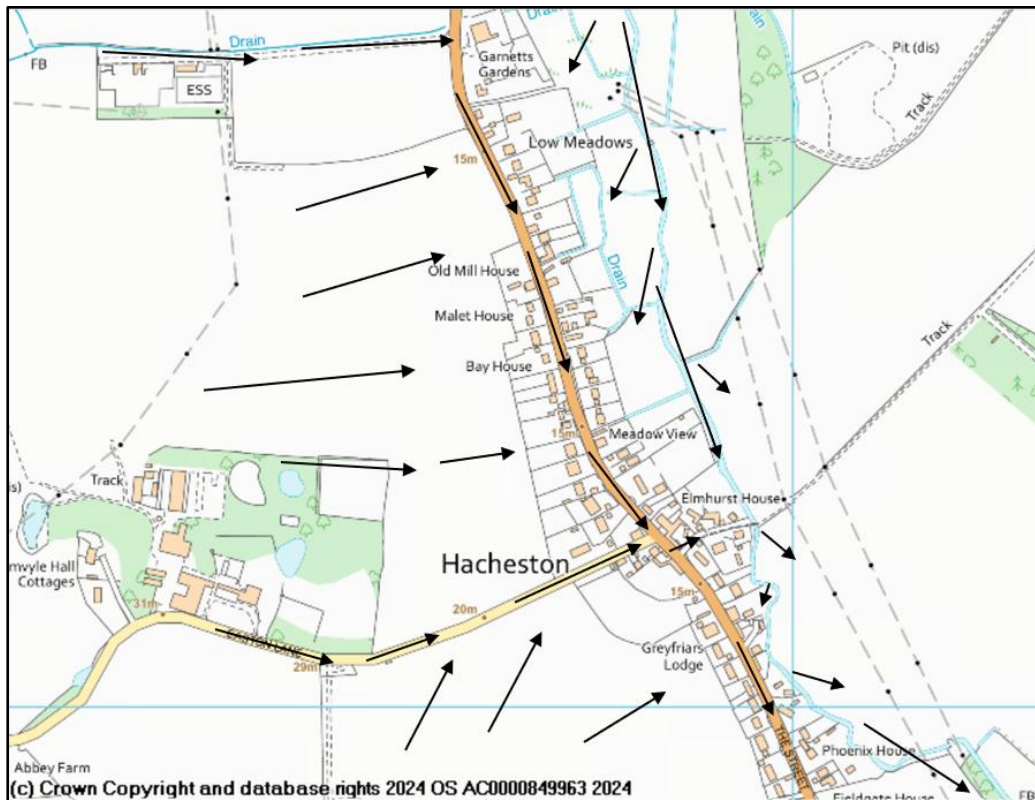
Figure 18. Approximate floodwater flow routes in Hacheston

Floodwater flowed across fields to the west before emerging onto the carriageway, pouring through hedges and roadside verges. One of the issues reported by residents was the lack of ditches present along the lower boundaries of the fields to intercept and direct water away from housing and connect with the river behind. Many properties were flooded from the front as floodwater on the highway flowed onto driveways situated at a lower elevation and across dropped kerbs.

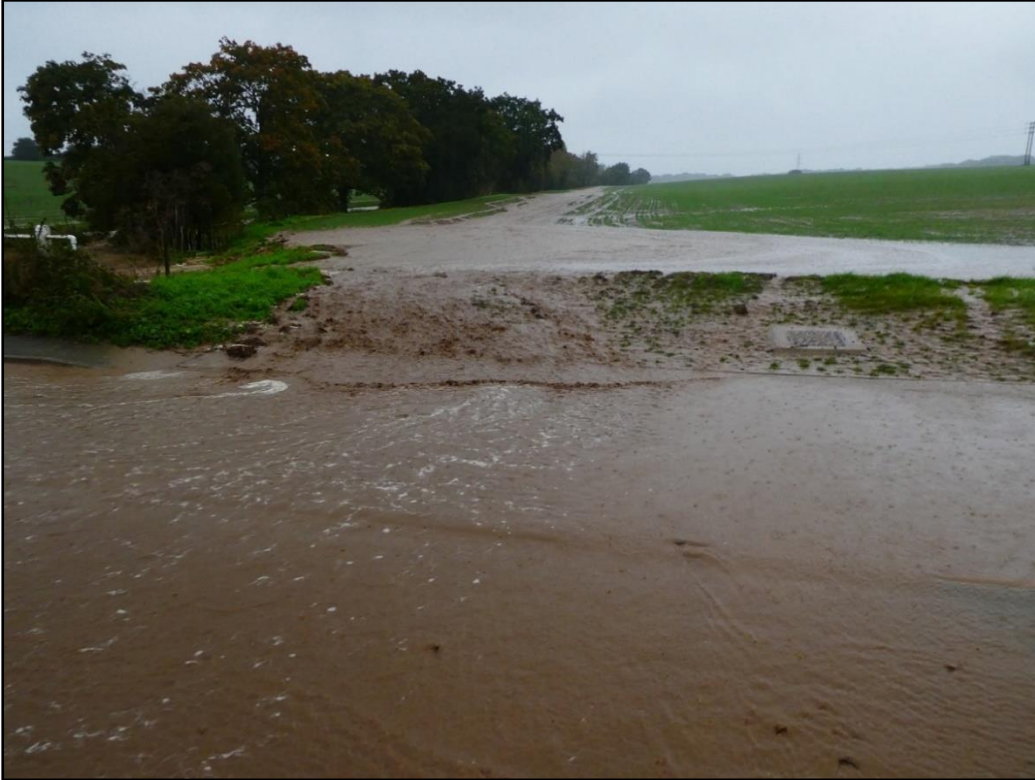
Image 5. Surface water flows from fields west of Hacheston

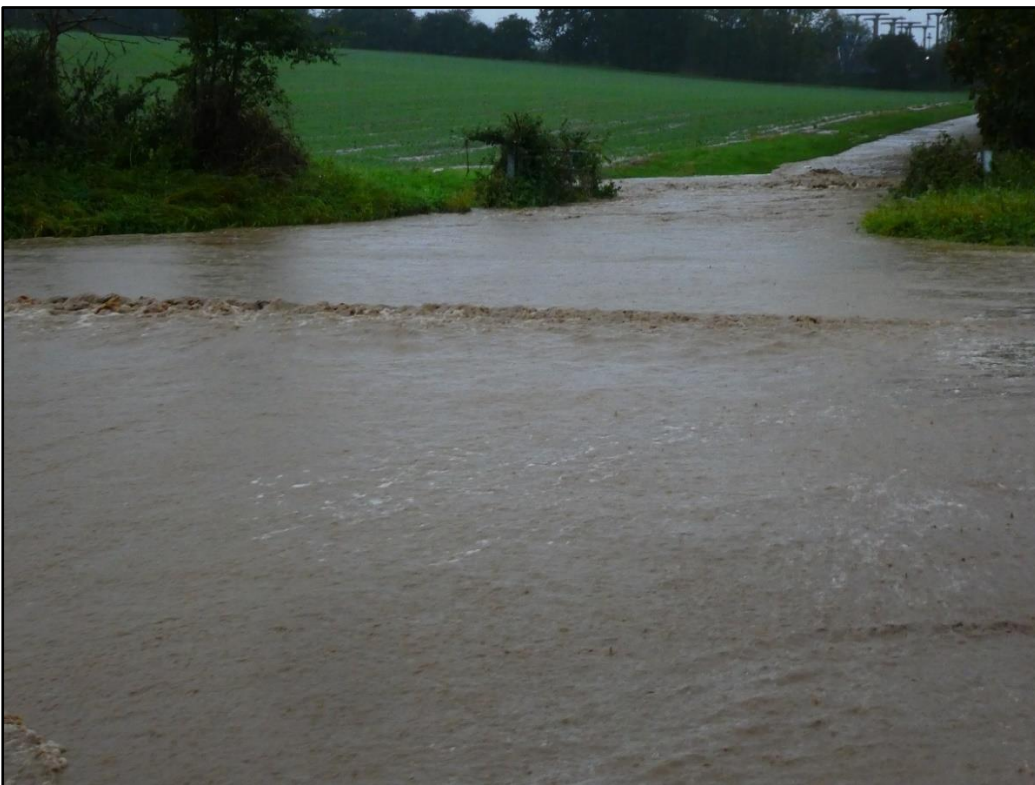
Image 6. Surface water runoff opposite Garnett's Garden Centre, Hacheston
