THE STREET, HACHESTON

**SURFACE WATER FLOOD RISK
TECHNICAL NOTE**

05th November 2025

5026555-RDG-XX-XX-RP-C-0502

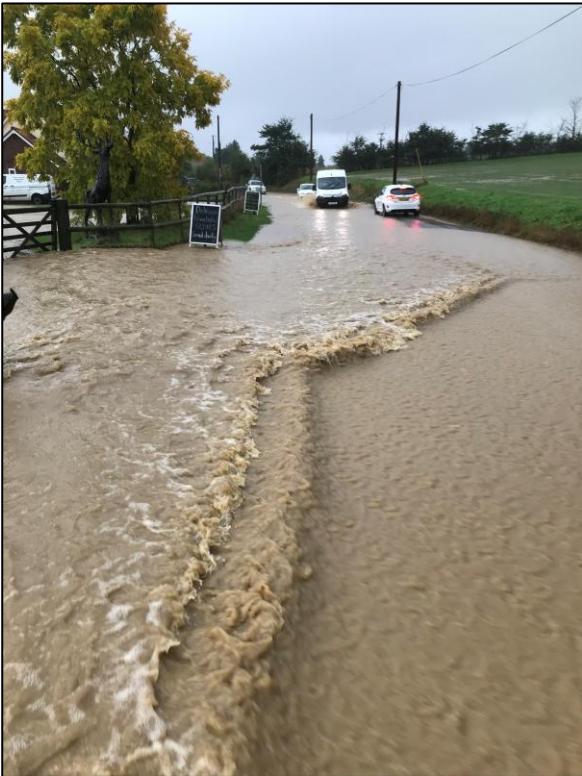
Photo 1: Significant highway flooding outside Garnetts Gardens

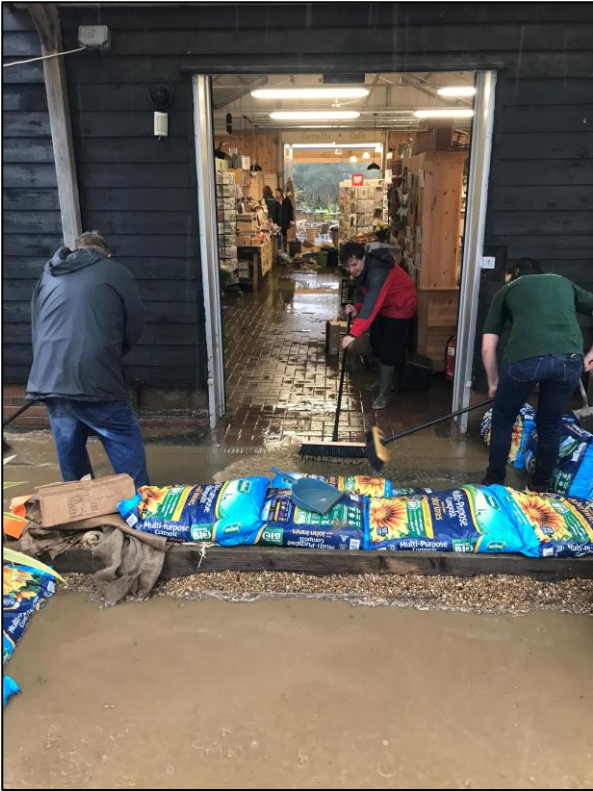
Photo 2: Clear-out following internal flooding to Garnetts Gardens

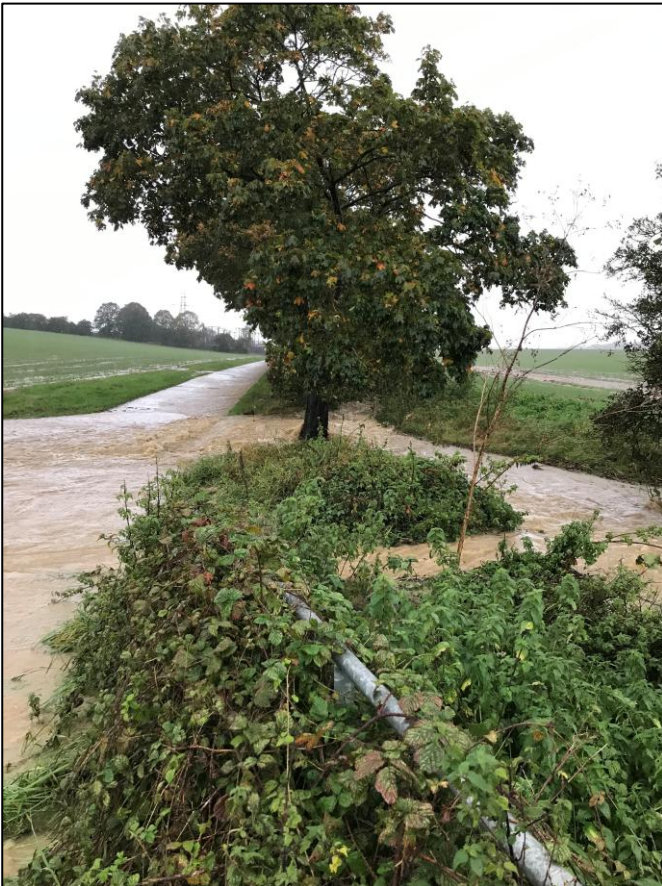
Photo 3: Exceedance of ditch capacity upstream of highway culvert opposite Garnetts Gardens

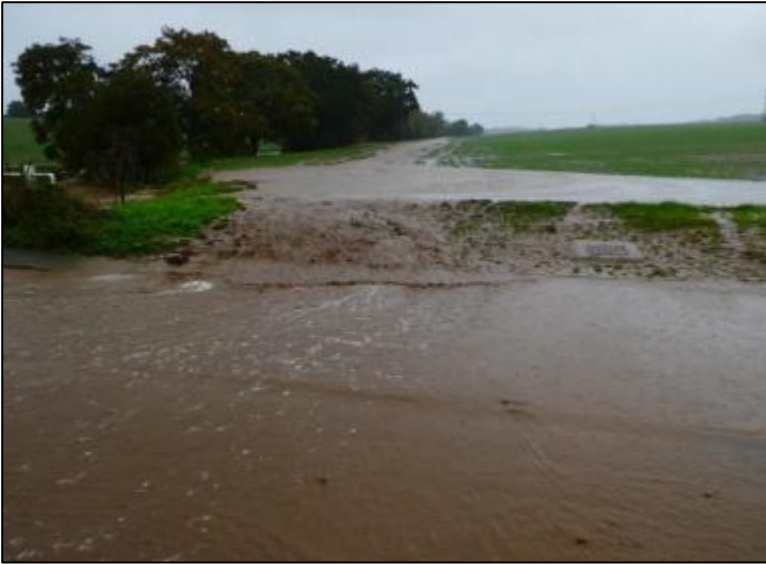
Photo 4: Surface water overland flow across fields onto highway towards Garnetts Gardens

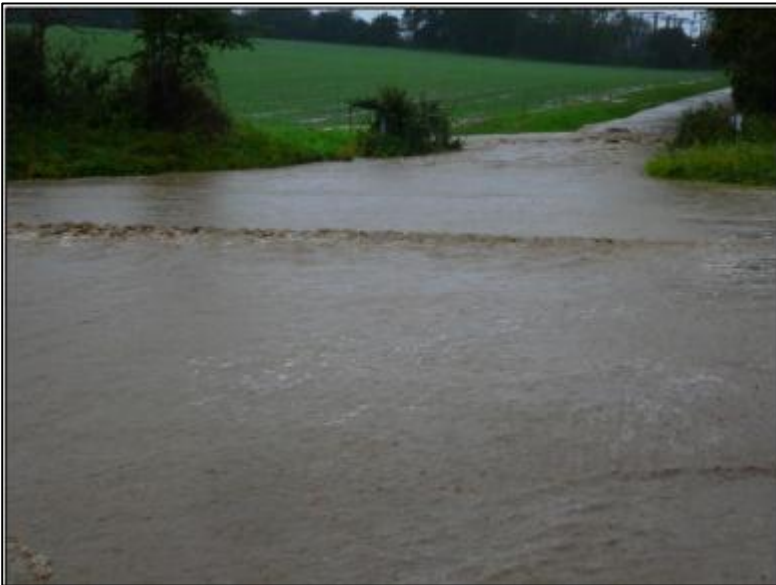
Photo 5: Surface water runoff from highway culvert ditch, access track, and fields onto highway towards Garnetts Gardens

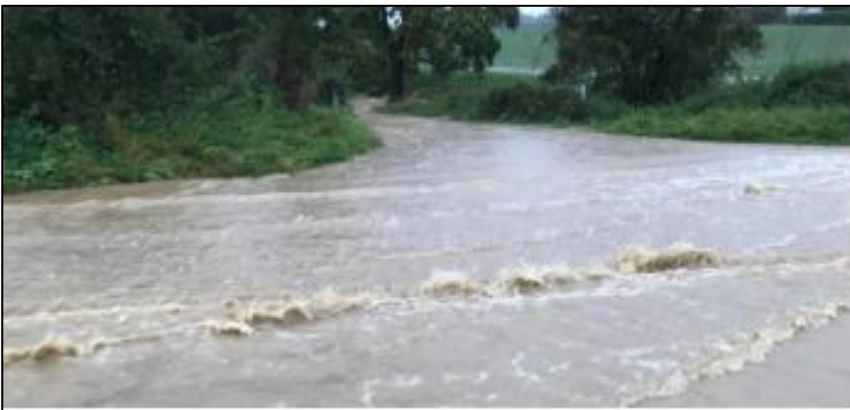
Photo 6: Flooding at junction opposite Garnetts Gardens

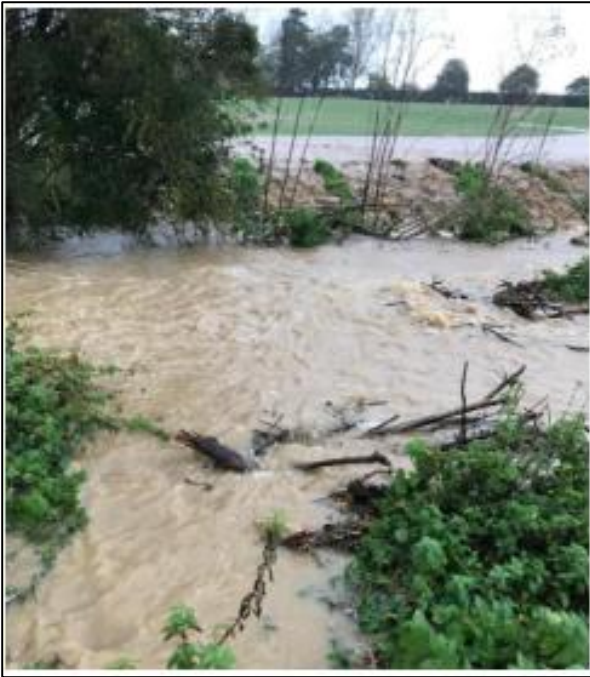
Photo 7: Ditch overflowing upstream of highway culvert opposite Garnetts Gardens.

- The highway culvert opposite Garnetts Gardens has been dug out since Storm Babet, however it is noted that culvert needs clearing regularly to ensure the culvert is kept clear.
- Meetings with the highway authority have been arranged following Storm Babet to discuss and survey drains, however these have been cancelled or postponed.
- The need for additional gullies, remedial works to drainage systems, and a dropped kerb have been raised with the highway authority.

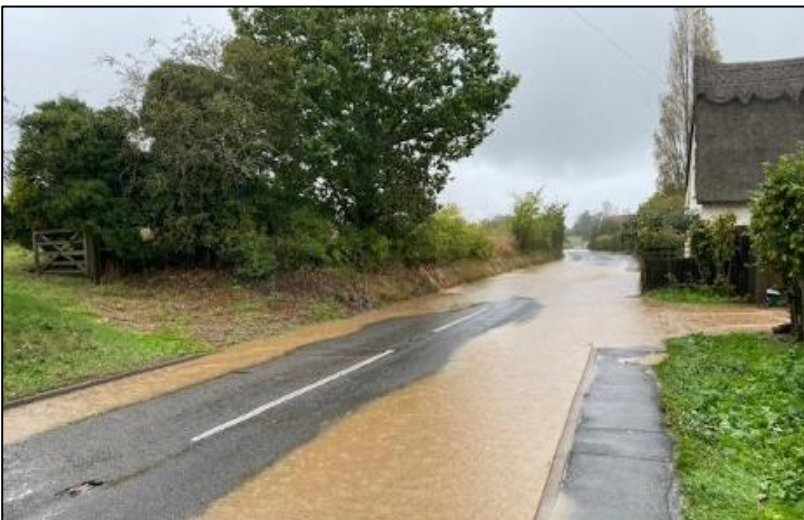
Photo 8: Flooding along 'The Street' approx. 250m south of Garnetts Gardens outside Thatched Cottage.

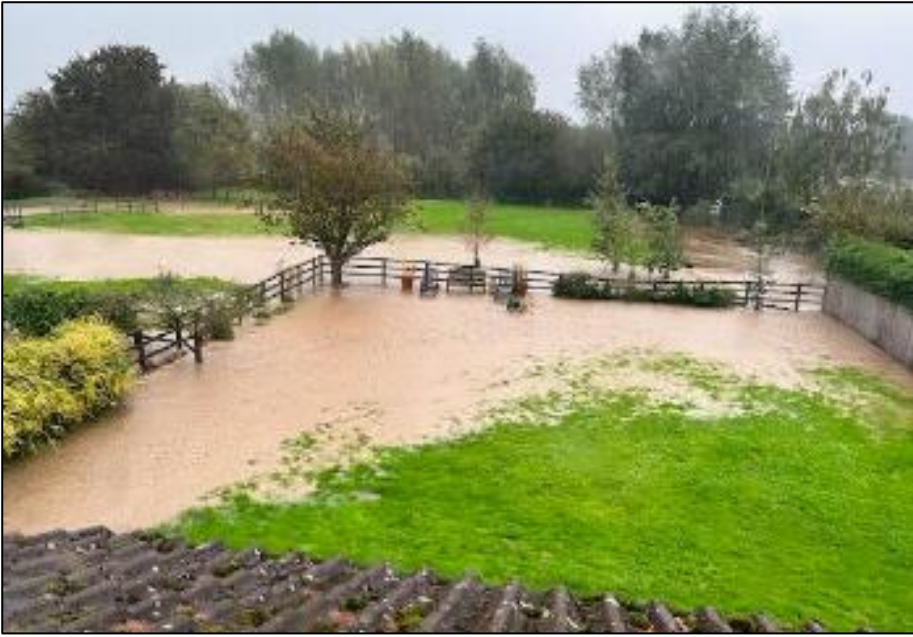
Photo 11: View towards River Ore to rear of properties along 'The Street'

The fluvial (river) flood risk mapping illustrated in Figure 4 indicates that the floodplain associated with the River Ore extends across the rear gardens of properties along The Street. Whilst internal property flooding from the River Ore may not have previously occurred, it has been reported by residents in the 'Local Evidence Collection' note that the elevated water levels observed in the River Ore, and ditches connected to the floodplain, had limited/ no capacity to receive the vast amount of surface water from the western agricultural catchment. It is likely that the elevated river levels were a contributing factor in how efficiently the highway was able to drain, exacerbating the flooding and standing water around the highway culvert (opposite Garnetts Gardens) and gullies along The Street (noting that blockages from silt and debris were also reported as clogging the storm drainage systems).

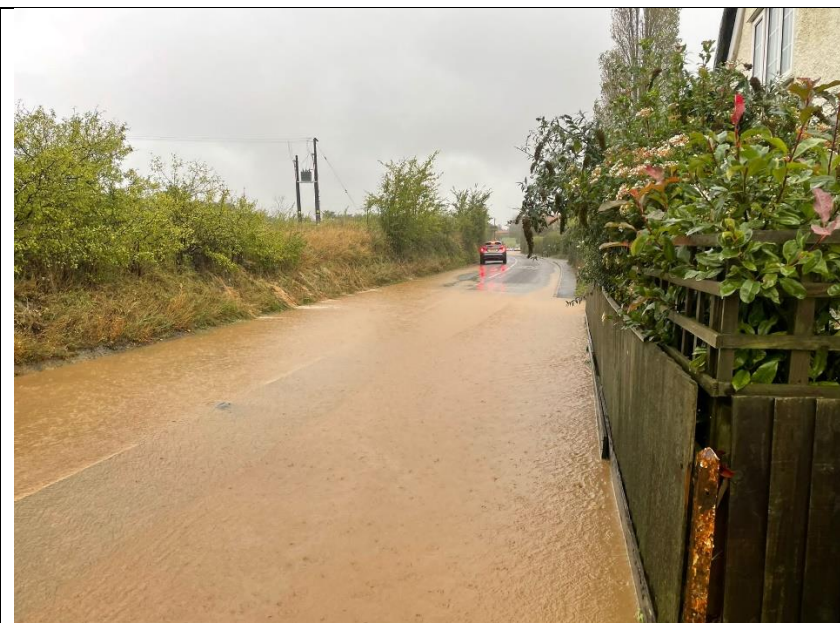
overland flow from field opposite Thatched Cottage:

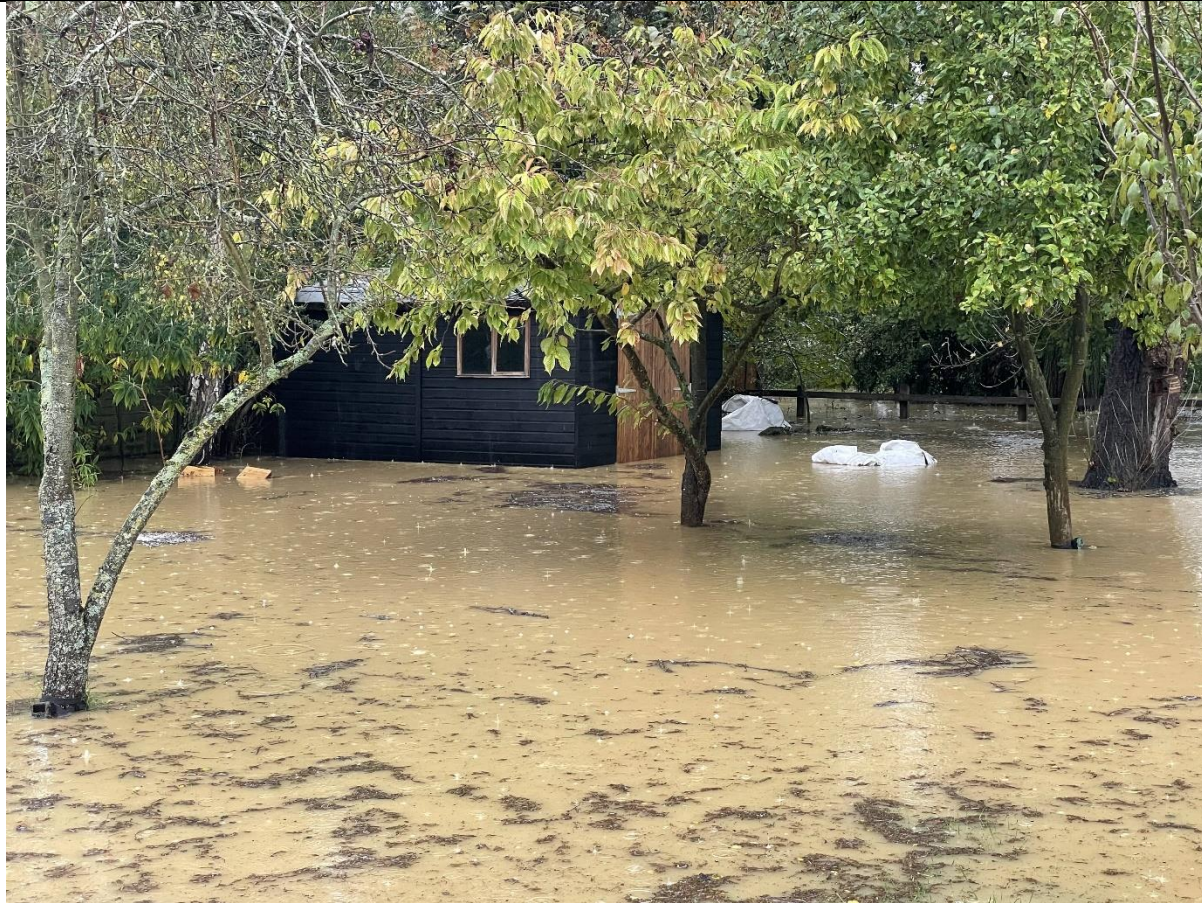
///massaging.auctioned.salad

Garden at Thatched cottage : Photo taken facing North East

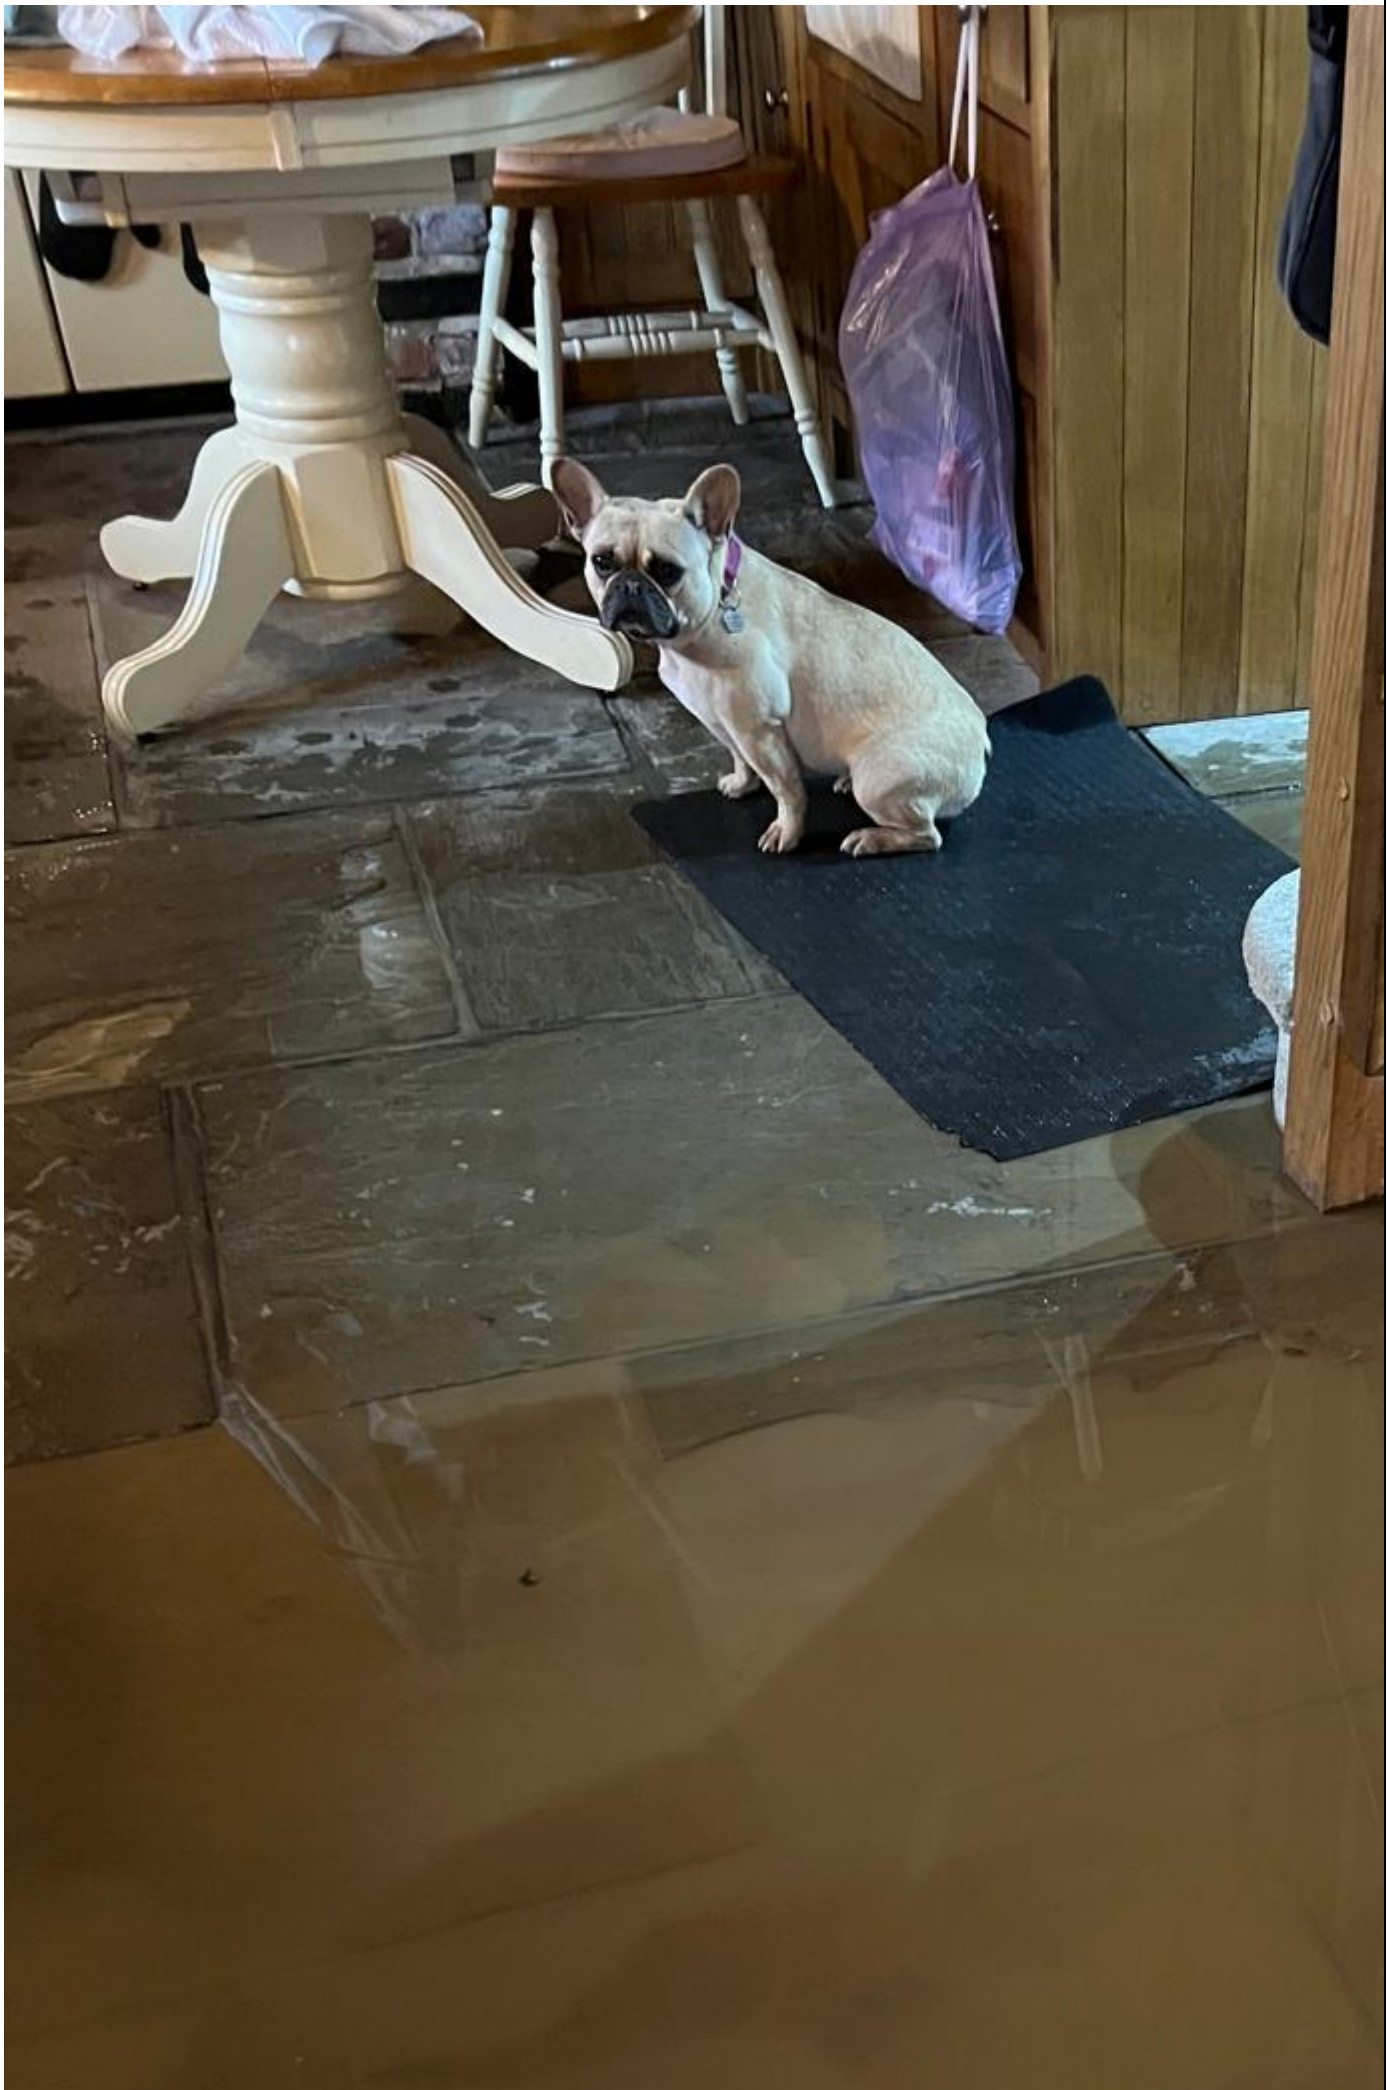
PC: Ty Brook: W3W: ///dressy.destroyer.memo

You can see that the water was coming mainly off the field opposite like various waterfalls along the road and down the lower laying driveways of the houses.

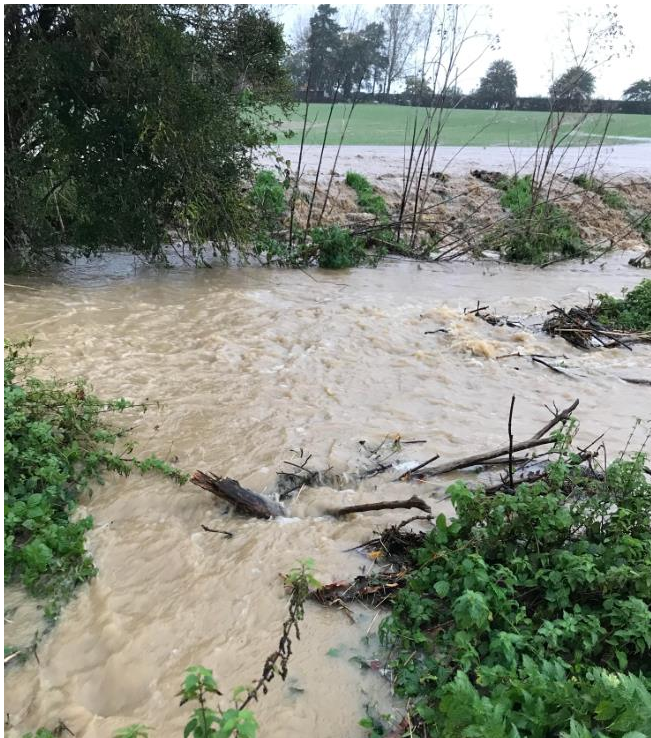
Culvert opposite Garnetts garden centre over flowing on to B1116
Photo taken facing sSouth West W3W ///various.upwardly.diamonds

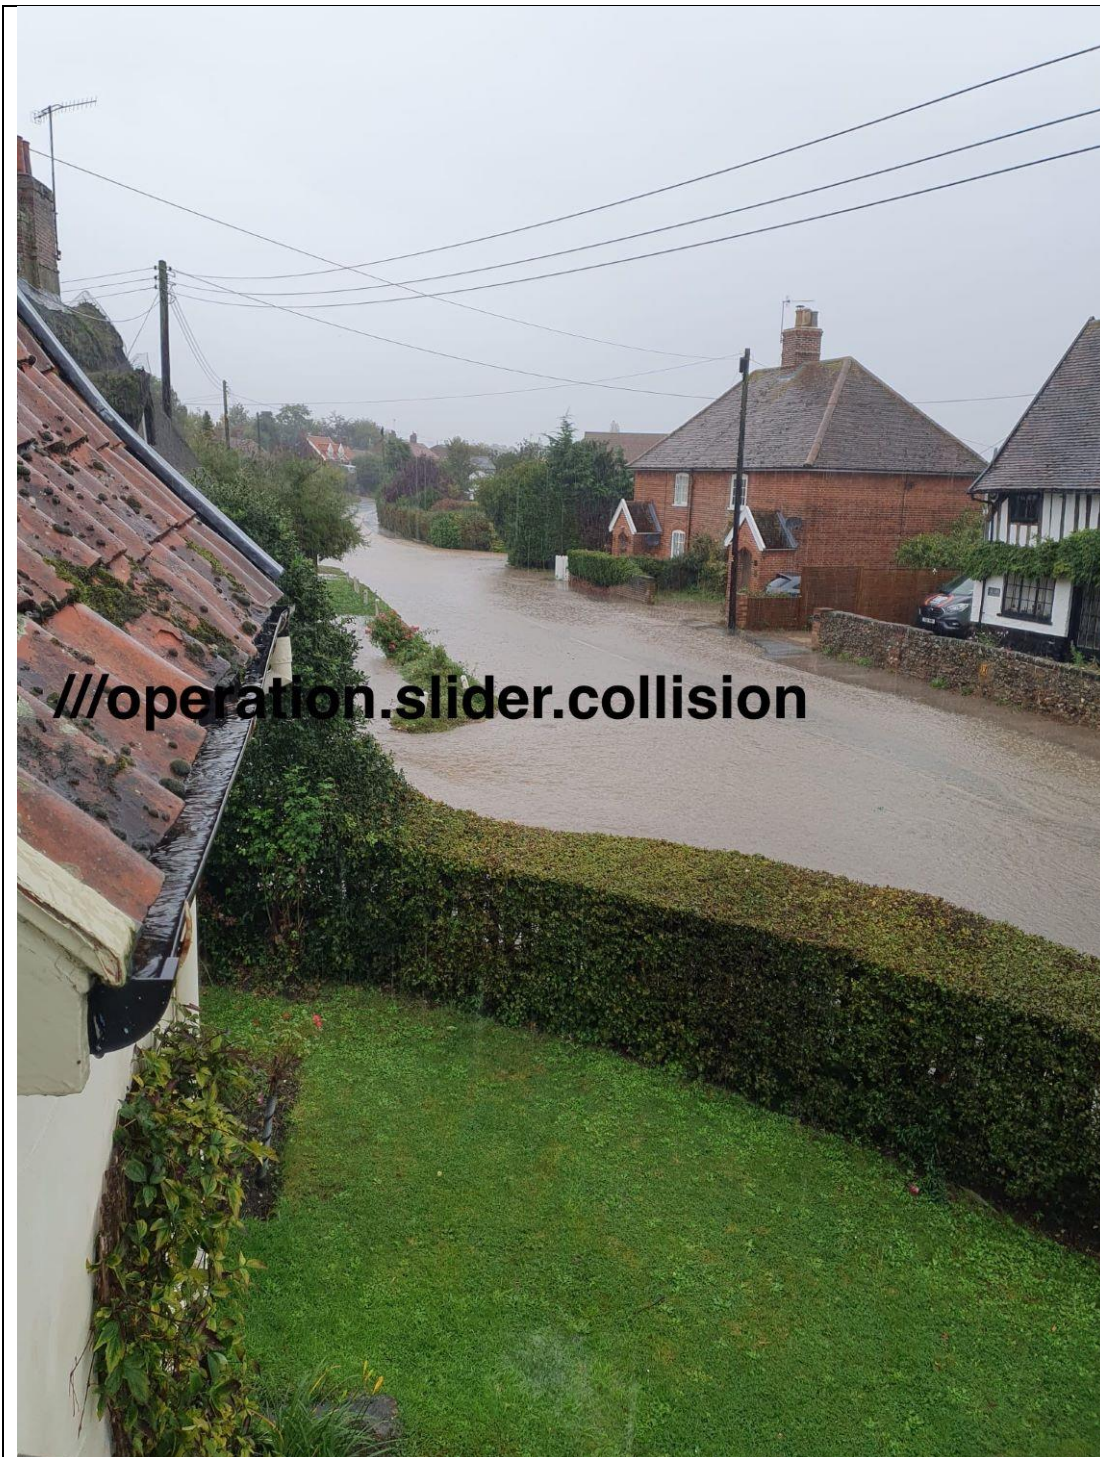
Photo taken facing North

Easton lane - a number of drain on Easton lane get blocked from the debirs from field and the water runs down the lane onto the main road . There are some land drains from the field that run directly onto Easton lane.

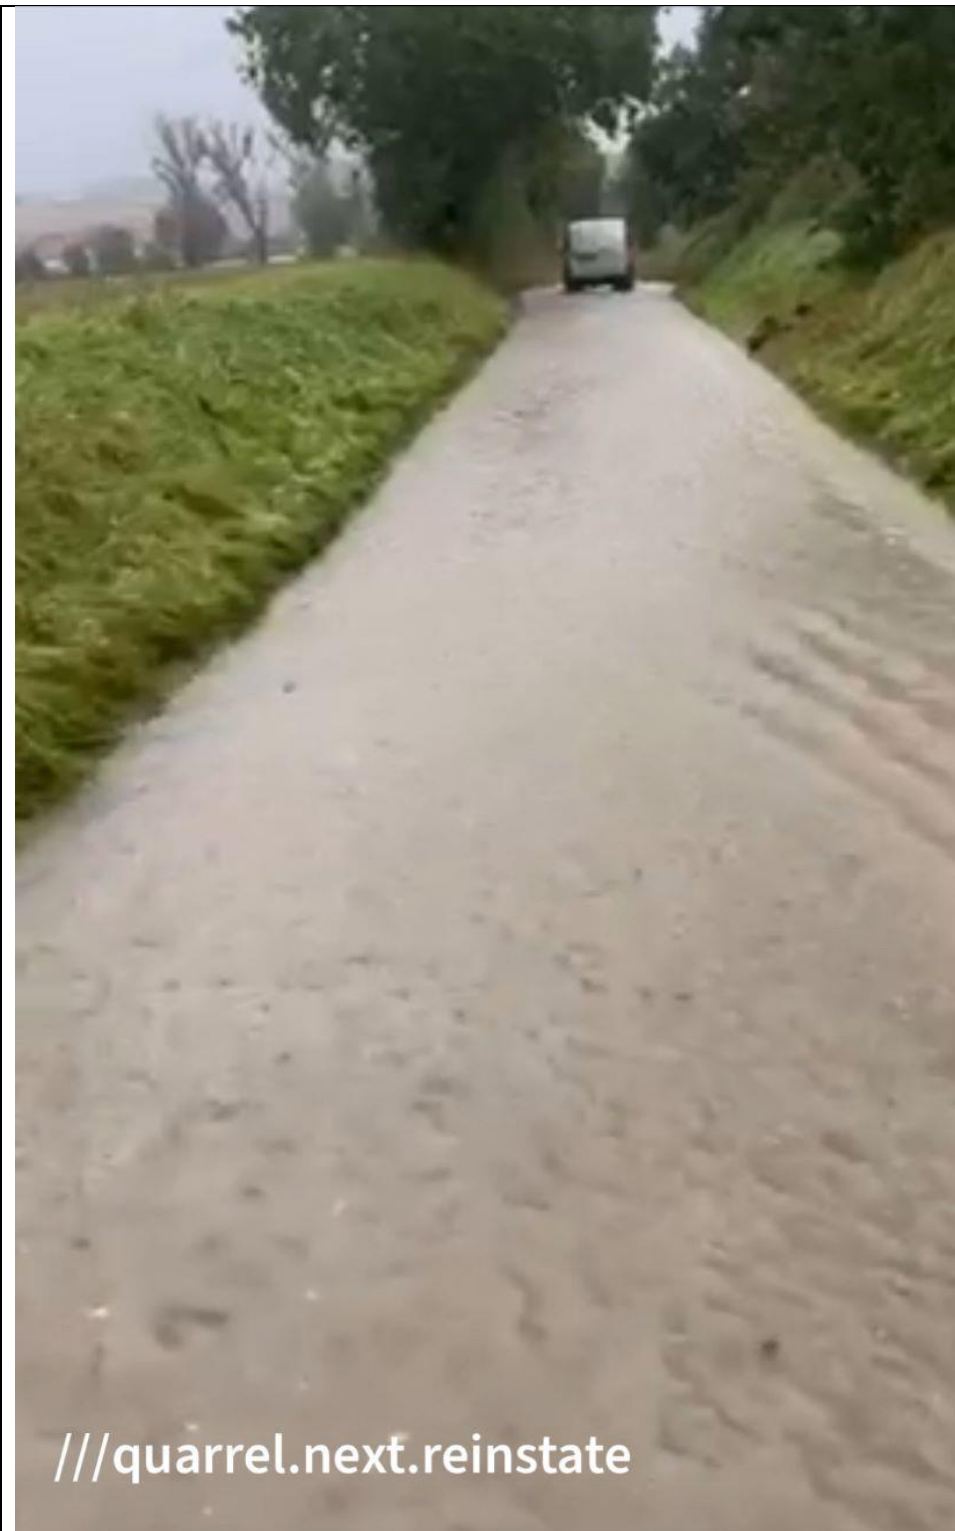
Photo taken facing East

Land drains run from fields directly into Easton Lane

Water running down Easton lane onto The street, hacheston. The water running down eatson Lane impacted a number of properties and caused the B1116 to flood .

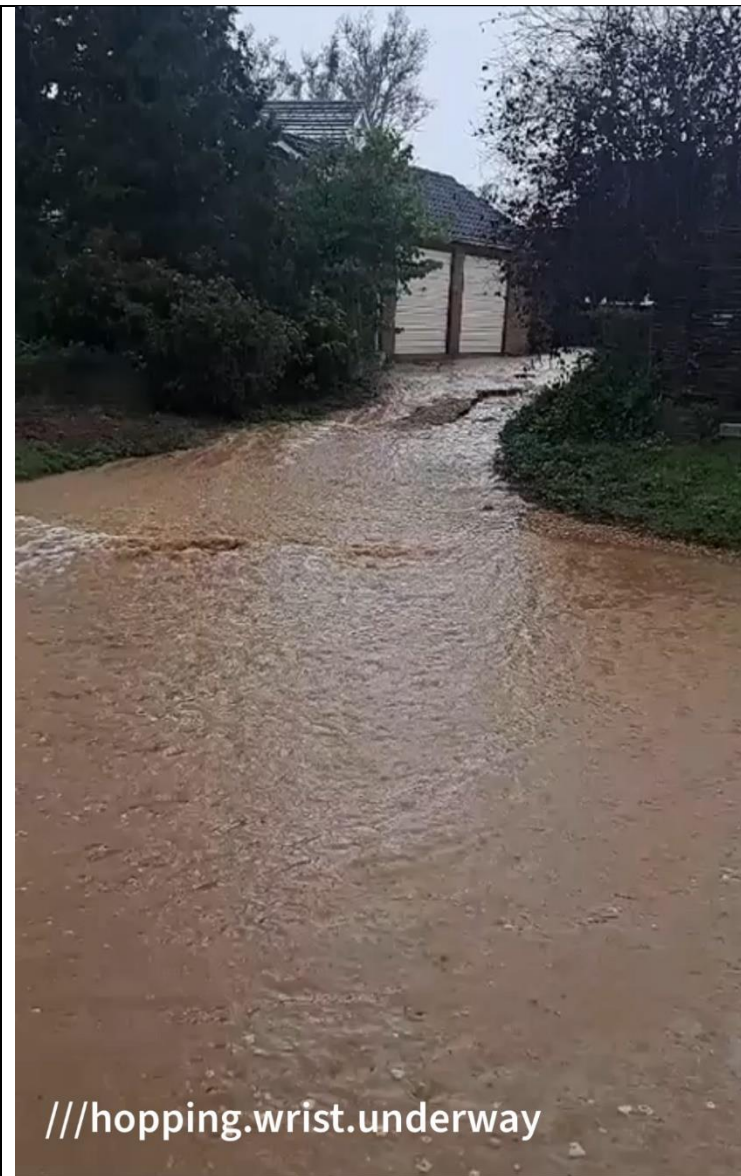
Water running off fields through gardens and homes to reach the road. Residents in the village attempted to slow traffic down to prevent the wake of the water running into their properties

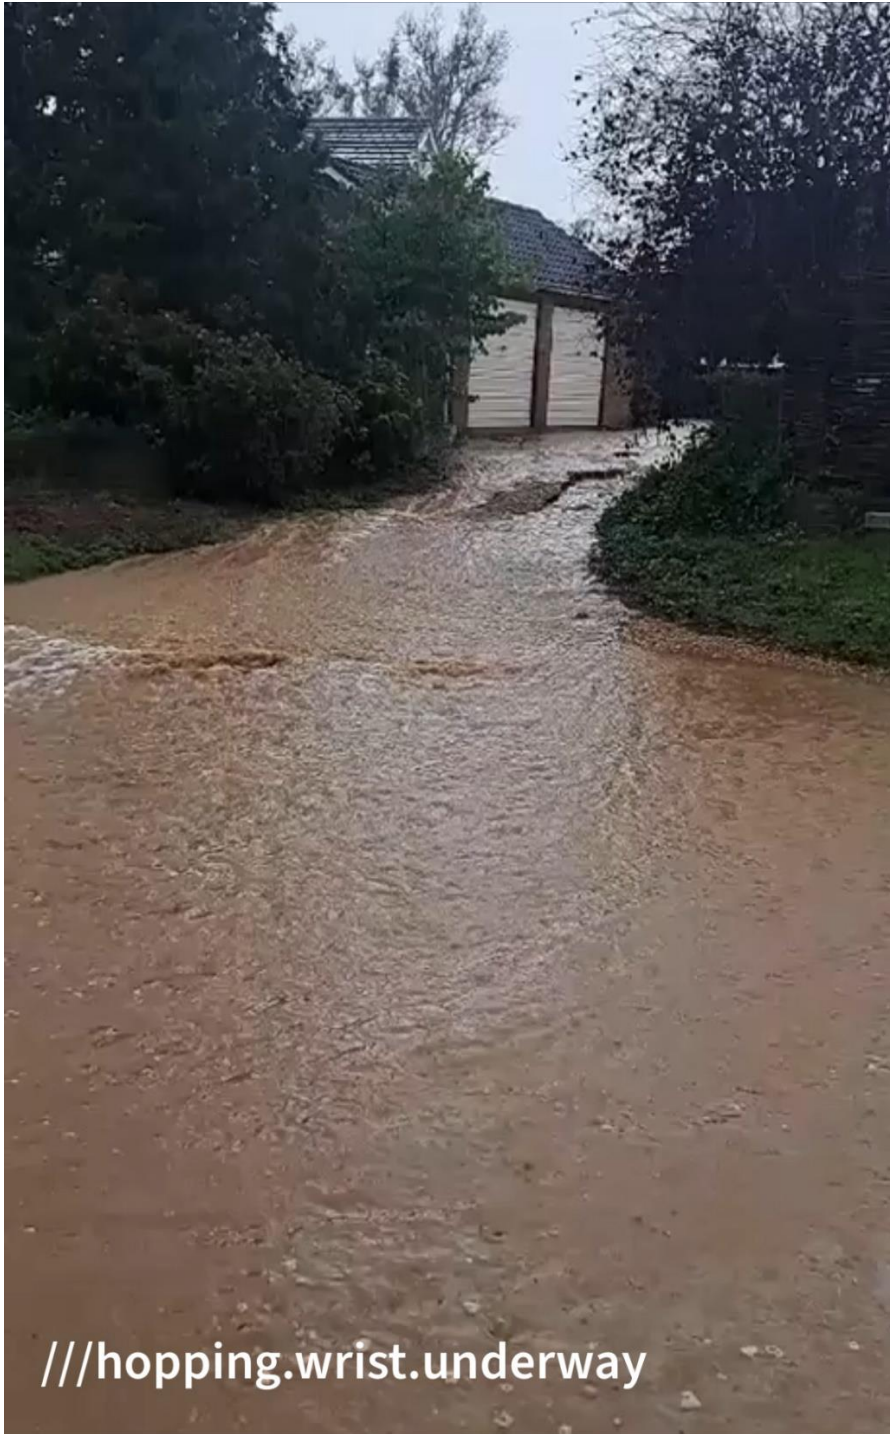
Photo taken facing West

Water pouring off fields through property onto B1116

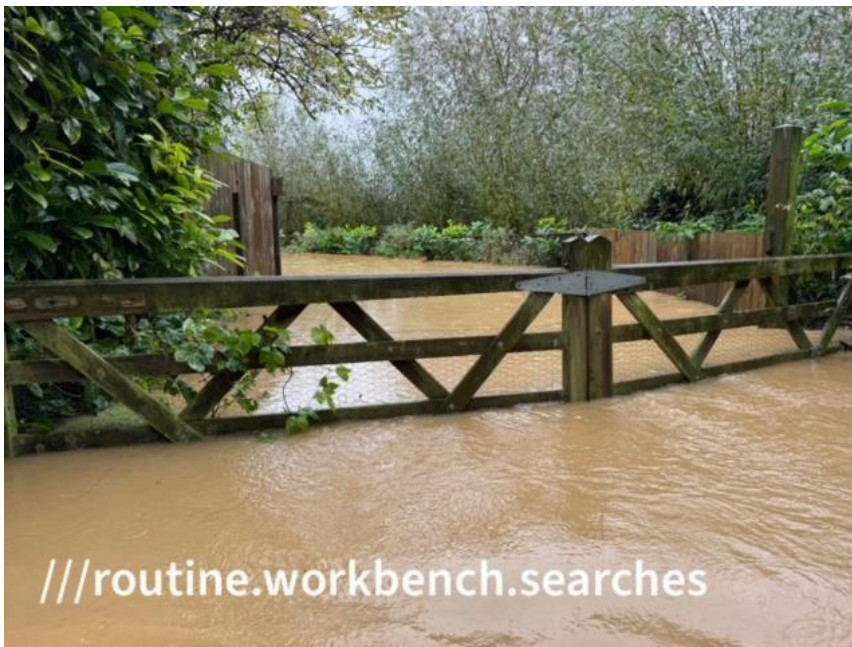
Photo taken facing North at about 4pm from the other side of the gate
Water continued to rise another 100mm until peak at 6pm

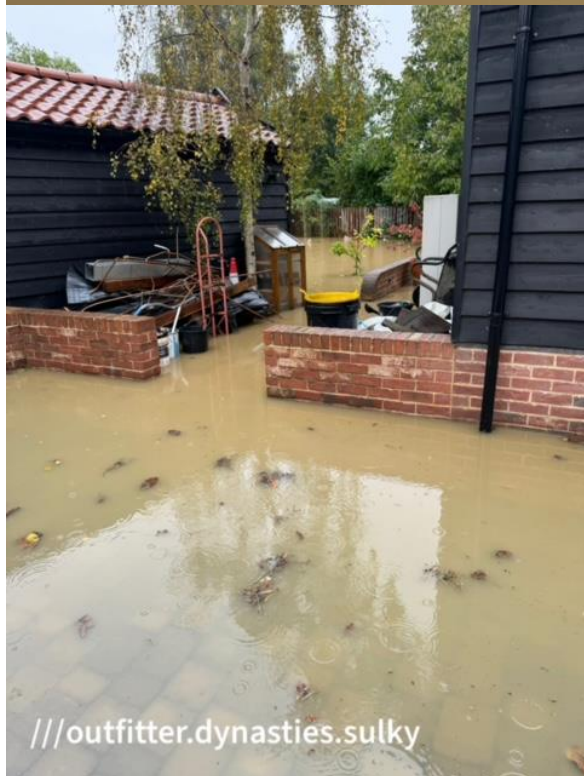
Photo taken facing North water levels were up to 700mm deep here at 6pm

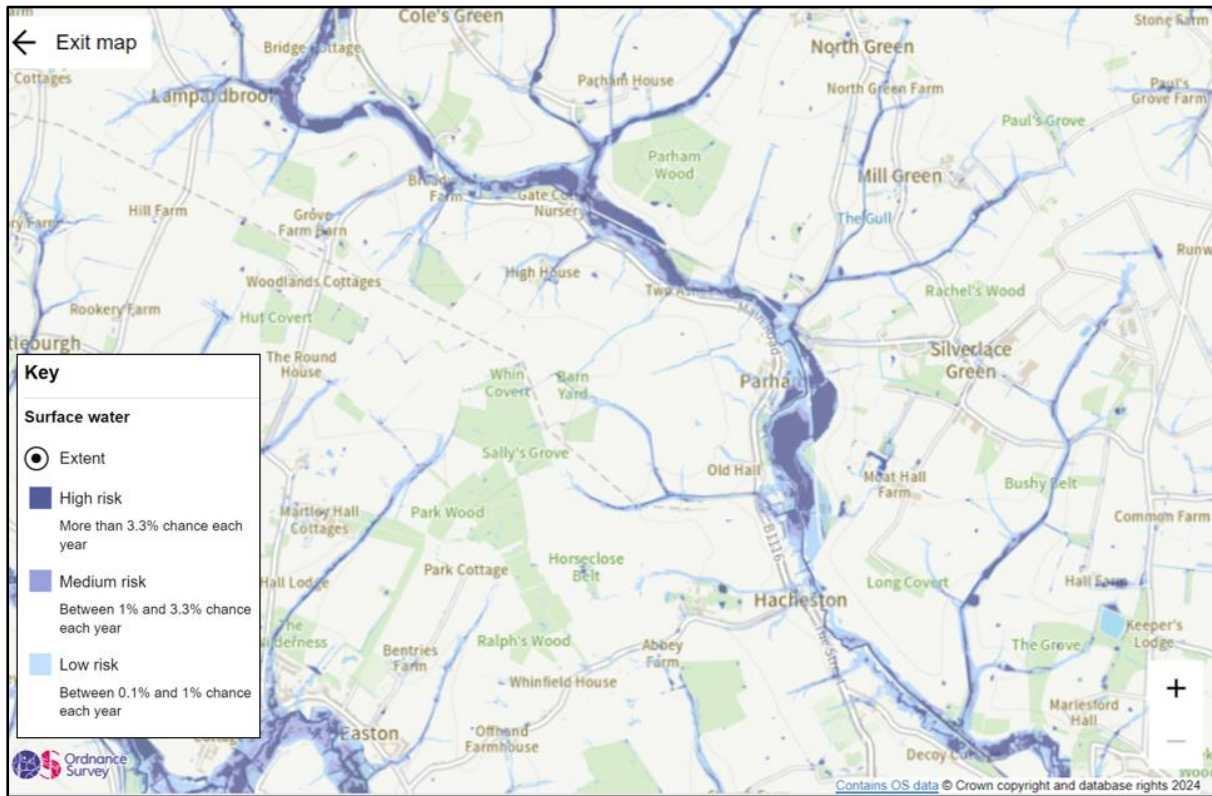
Figure 6. Predicted surface water flood risk

Figure 6 highlights the predicted pluvial (surface water run-off from surrounding land and ditches) flood risk in Parham and Hacheston, with multiple major flow paths coming into Parham from the northeast, north and west. Surface water flow paths come into Hacheston predominately from fields to the west.

There is significant predicted risk of surface water flooding on North Green Road, The Street and sections of Main Road northwest of Parham. These areas were affected by flooding during Storm Babet.

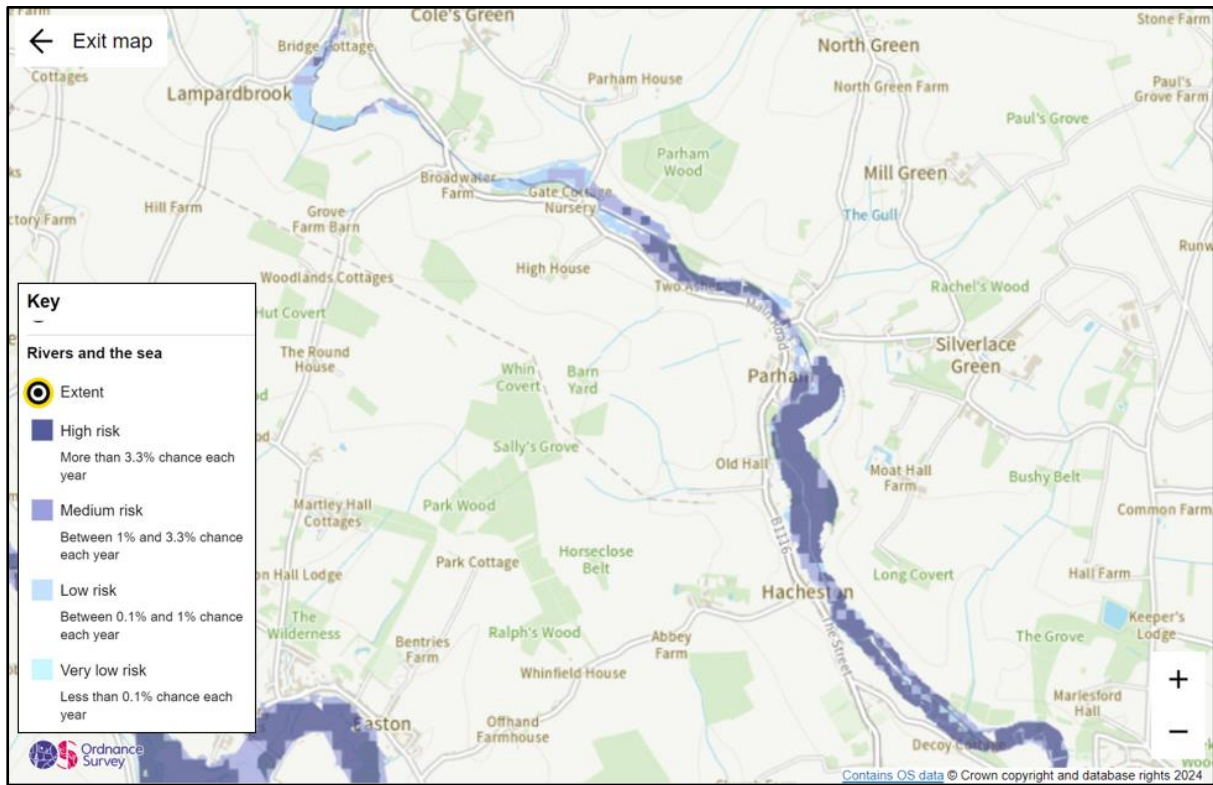
Figure 7. Predicted flood risk from rivers and sea

Figure 7 highlights the predicted fluvial (from designated main river and ordinary watercourses) flood risk in Parham and Hacheston. Fluvial flood risk in Parham and Hacheston is associated with the river Ore which passes through both villages.

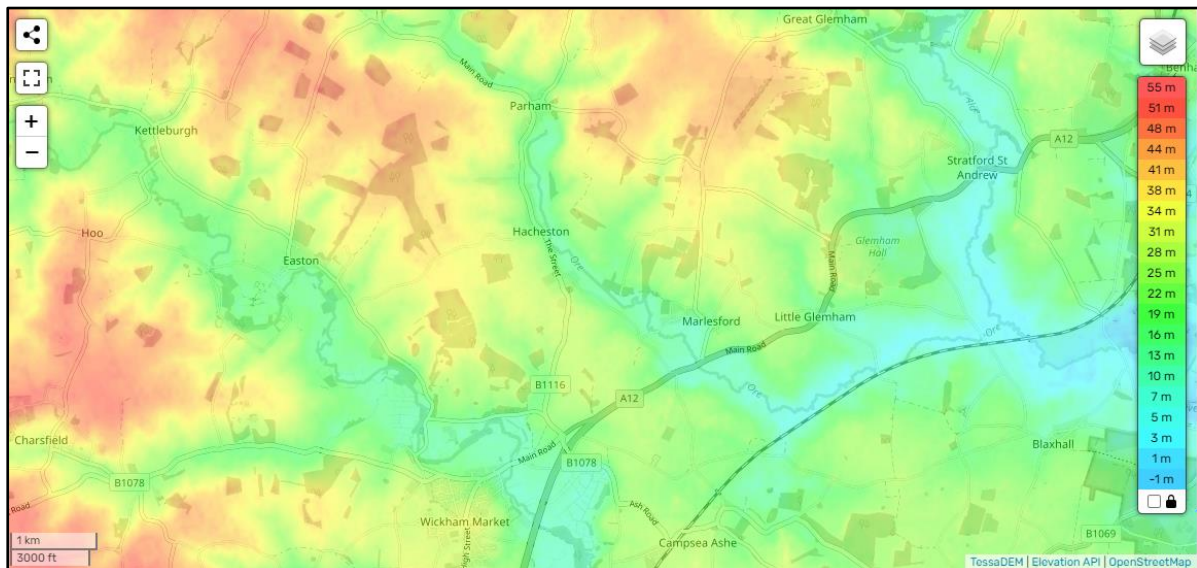
Figure 8. Parham, Hacheston and surrounding topography (TessaDEM as cited in topographic-map.com)

Figure 8 shows the topography surrounding Parham and Hacheston with gradient changes across both. Both villages are lower than the surrounding land. The lowest points in Parham are along The Street and Main Road which are among the areas that were affected by flooding. The Street and eastern end of Easton Lane are among the lowest lying locations in Hacheston. These were identified as being some of the worst affected areas during Storm Babet.

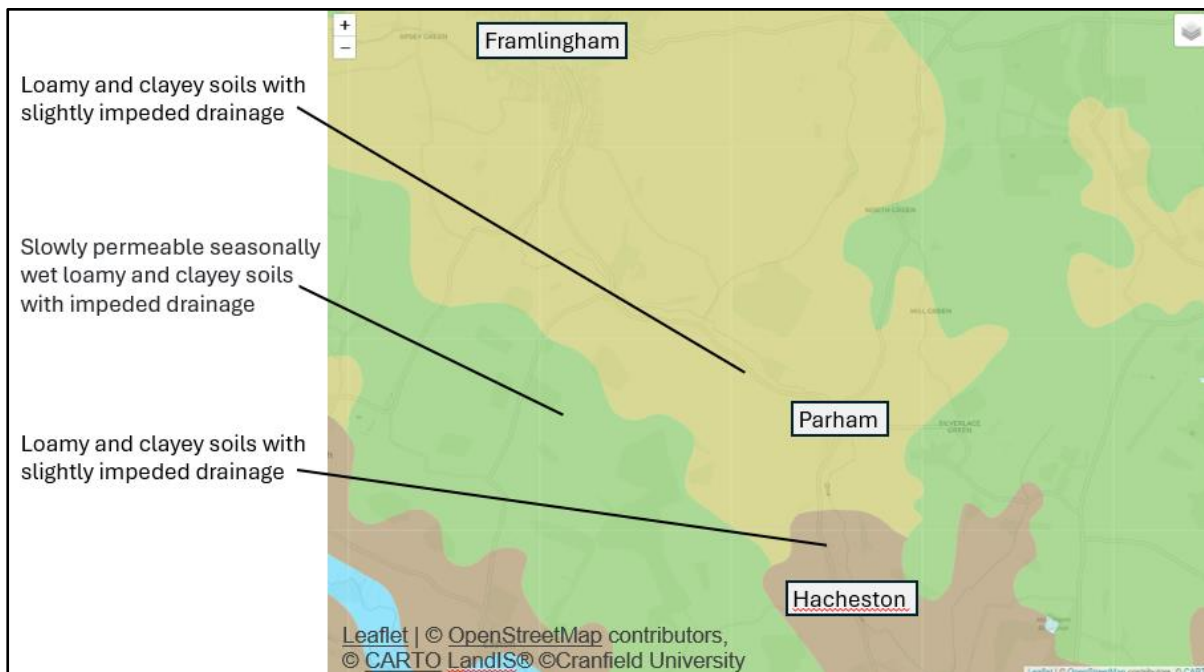
Figure 9. Soil map of catchment area (LandIS Soilscape)

The soils surrounding Parham and Hacheston are loamy and clayey with impeded or slightly impeded drainage, meaning that water permeates more slowly and surface water runoff is greater. With regards to soils, Parham and Hacheston are situated on alluvium, mostly sand and gravels with a mixture of clay and silts. The floodplain soils surrounding the river Ore usually have naturally high groundwater and tend to be wetter.

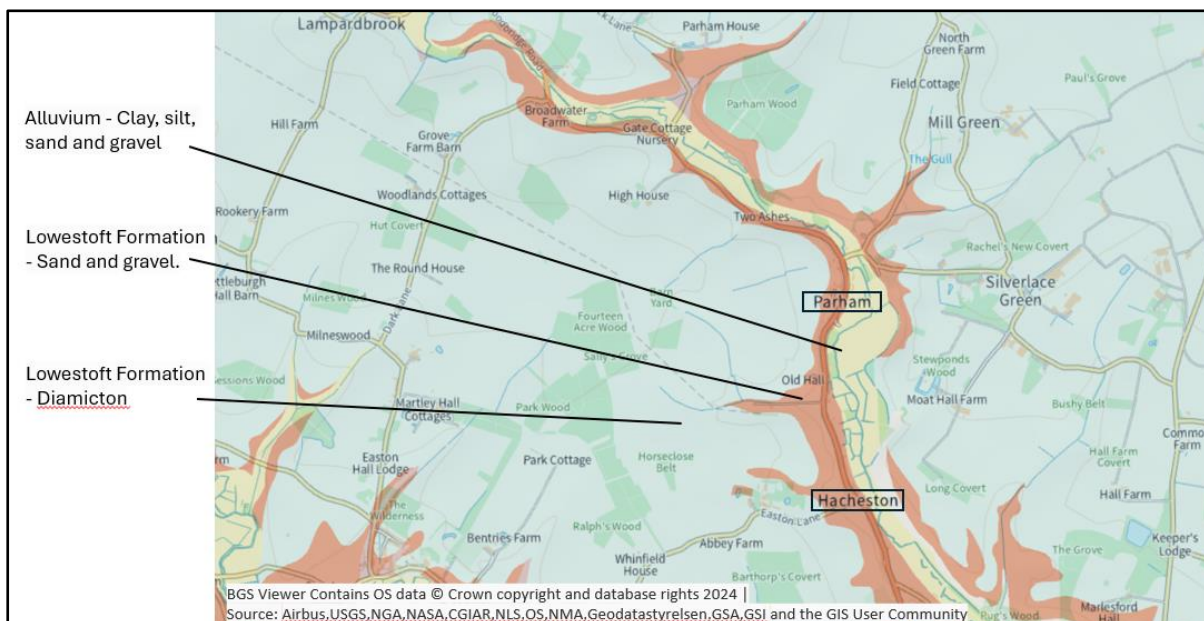
Figure 10. Superficial Geology (BGS Viewer)

Lowestoft Formation 'Diamicton' surrounds the villages of Parham and Hacheston which is described by the British geological Survey as a diverse mixture of clay, sand, gravel, and boulders varying widely in size and shape. This generally has a low permeability meaning water will tend to flow off it before it can be infiltrated, which reflects some of the reports from the Storm Babet event.

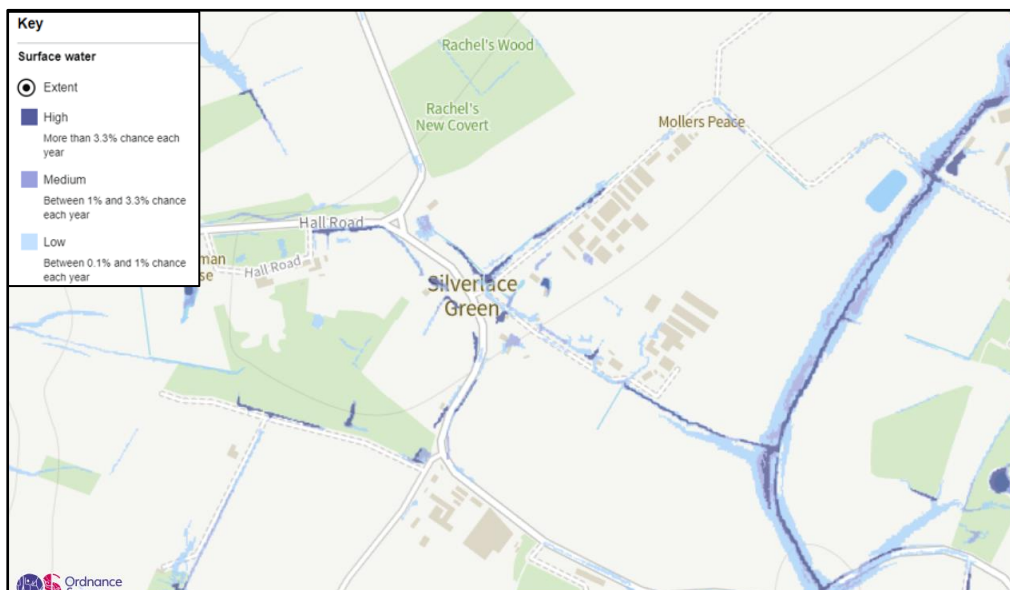
Figure 12. Surface Water flood risk on Hall Road

Intense rainfall caused surface water to flow across the fields and overwhelm the ditches from the north and east towards Hall Road. Internal flooding occurred from the rear as floodwaters spread into gardens and across the carriageway.

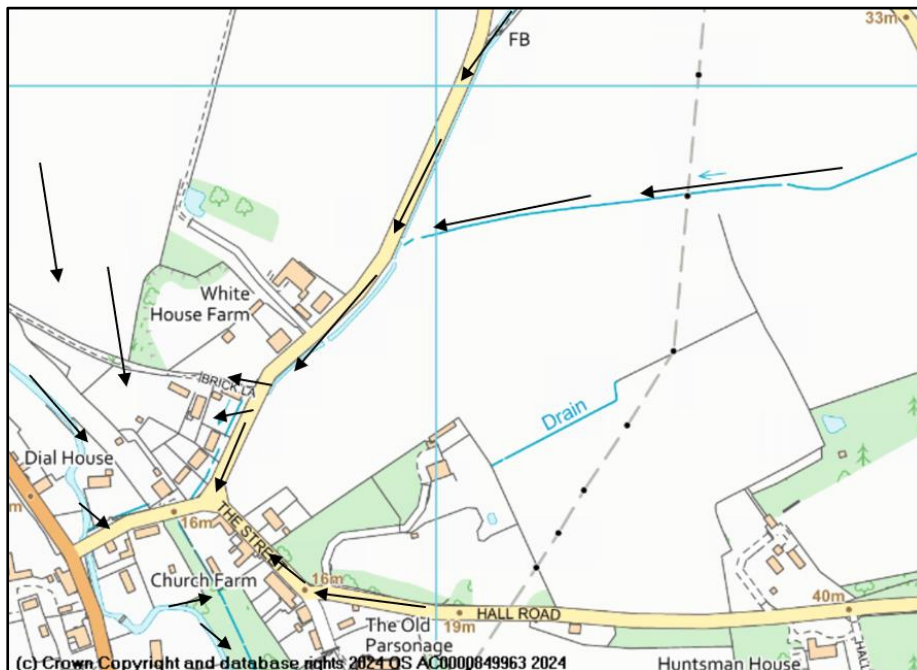
Figure 13. Approximate floodwater flow routes on The Street, Brick Lane and North Green Road

Properties on The Street were impacted by surface water flooding originating as run off from fields and ditches as well as the highways to the east and northeast along North Green Road and Hall Road. Following heavy rainfall on the morning of 20 October, the surface water was carried along these flow paths into the village (see Figure 10) exceeding the capacity of drainage features. Properties on Brick Lane were impacted as the Gull watercourse along North Green Road, overtopped and added to the floodwater already on the road (see Image 4).

The conveyance of the floodwater in the channel was restricted by the presence of culverts and a build-up of silt immediately downstream of the road bridge opposite Brick Lane causing the floodwater to backup and overflow out of the channel. There was also a significant amount of surface water that travelled along the highway.

- Investigate potential NFM projects to ‘slow the flow’ and attenuate water on overland flow paths (leaky dams, restoration of watercourses, etc.) northeast and east of Parham.
- Investigate realignment of the old watercourse behind properties on north green road to reinstate connection with the river Ore.
- Silt buildup immediately downstream of the road bridge on north green road to be removed by SCC Highways.
- Report any observed blockages below the road bridge on north green road on the Suffolk Highways Online Reporting Tool.
- Landowners to carry out any watercourse / culvert maintenance to reduce flood risk as necessary as per their riparian responsibilities.
- Ensure the completion of highway drainage asset cyclic maintenance on North Green Road and The Street.
