THE STREET, HACHESTON

**SURFACE WATER FLOOD RISK
TECHNICAL NOTE**

05th November 2025

5026555-RDG-XX-XX-RP-C-0502

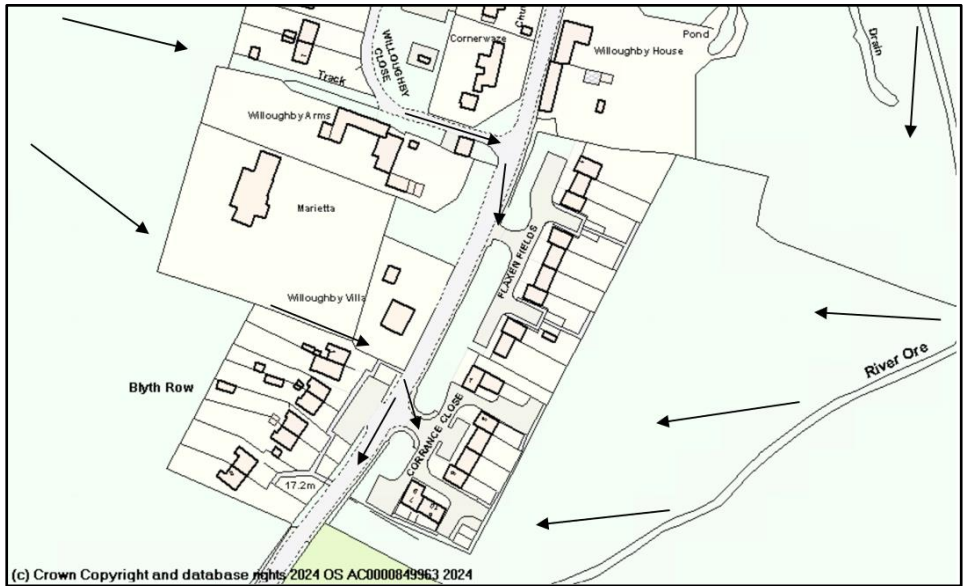
Figure 16. Approximate floodwater flow routes on Main Road and Corrance Close

The primary source of flooding suffered on this section of Main Road and Corrance Close was pluvial flooding from the adjacent fields to the west. Surface water flows coming across the fields flowed through and around properties from the back on the western side of Main Road and spilled onto the highway impacting Corrance Close from the front. The whole of the Corrance Close estate was described as being externally flooded by residents.

- Residents to install Property Flood Resilience (PFR) via grant funded scheme.
- Investigate potential NFM projects to 'slow the flow' and attenuate water on overland flow paths (leaky dams, restoration of watercourses, etc.) west of Parham.
- LLFA & East Suffolk Local Planning Authority to investigate the flooding on Corrance Close to fully understand the source and or if any possible flooding issues weren't accounted for in the development. Landowners to carry out any watercourse maintenance to reduce flood risk as necessary as per their riparian responsibilities.
- Ensure the completion of highway drainage asset cyclic maintenance on Main Road, Parham.

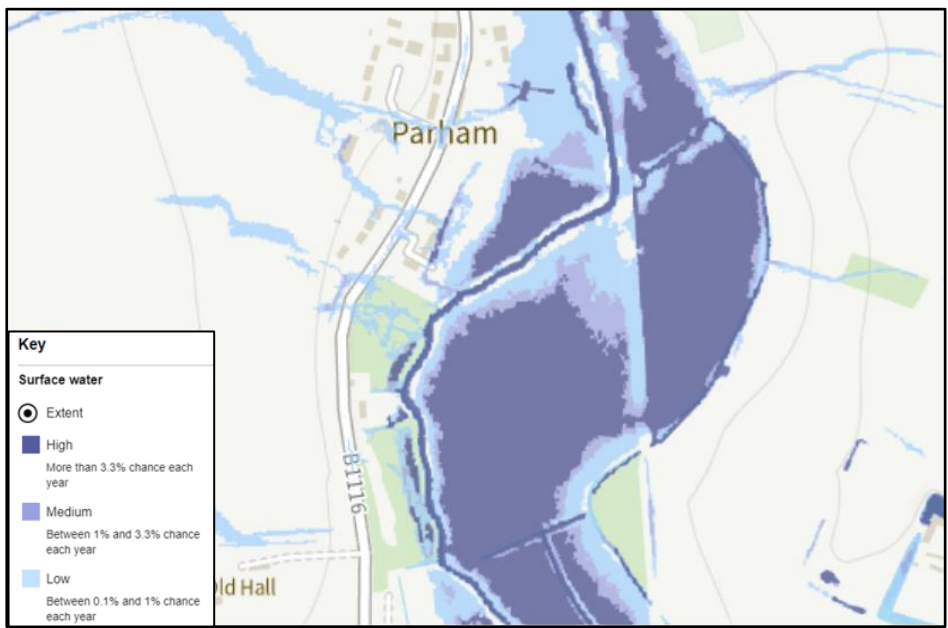
Figure 17. Surface Water flood risk on Main Road and Corrance Close

The observed floodwater flow paths and flood extents closely match the national predicted surface water flood risk mapping. Later in the day there was also fluvial flooding from the River Ore which impacted properties externally from the rear as the river levels continued to rise.

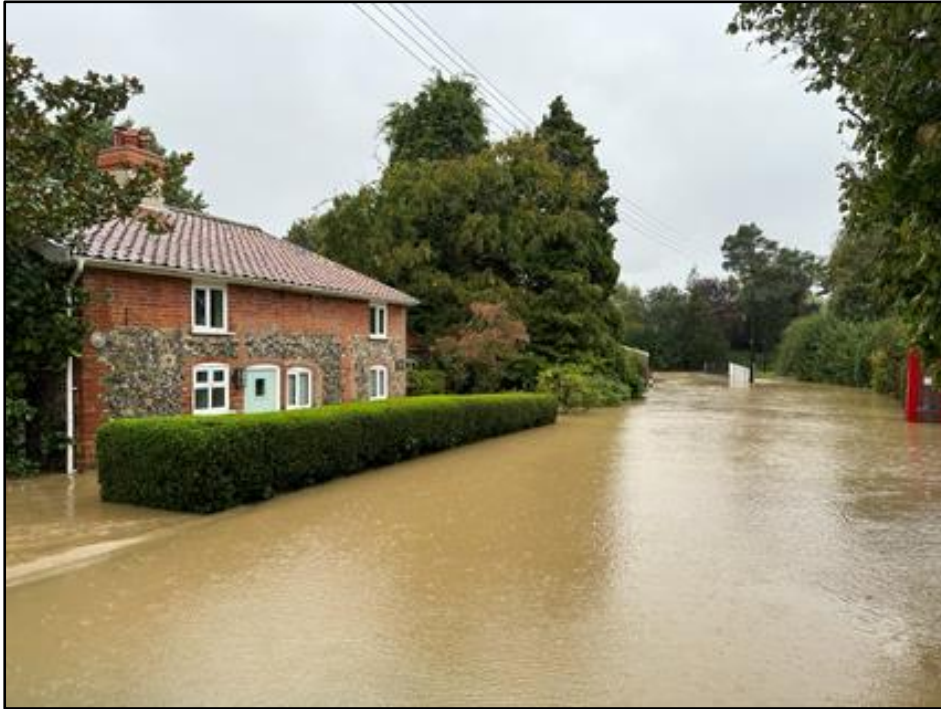
Image 1. Lower end of North Green Road

The surface water flows from the east and northeast then merged with the fluvial flood water coming from the overtopped river Ore at the lower end of North Green Road (see Image 1). Multiple properties reported internal flooding here as the river Ore breached the channel. The lower end of North Green Road was inundated in floodwater. The highway drainage system was completely overwhelmed with frequent

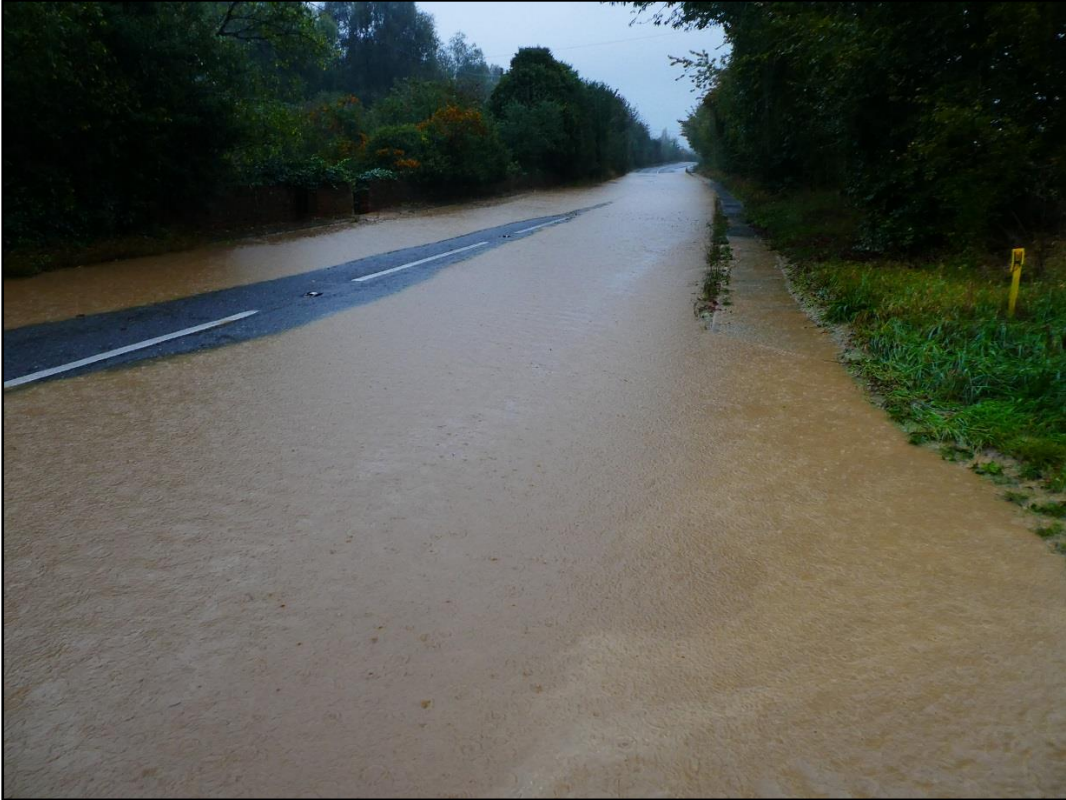
The overtopping of the watercourse occurred slightly north of the village and continued to breach the riverbank as it flowed through Parham. Flood water was on the highway and effectively created a second flow path along the road towards Hacheston and extended along the lower end of North Green Road toward The Street (see Image 2).

Image 2. Central Parham

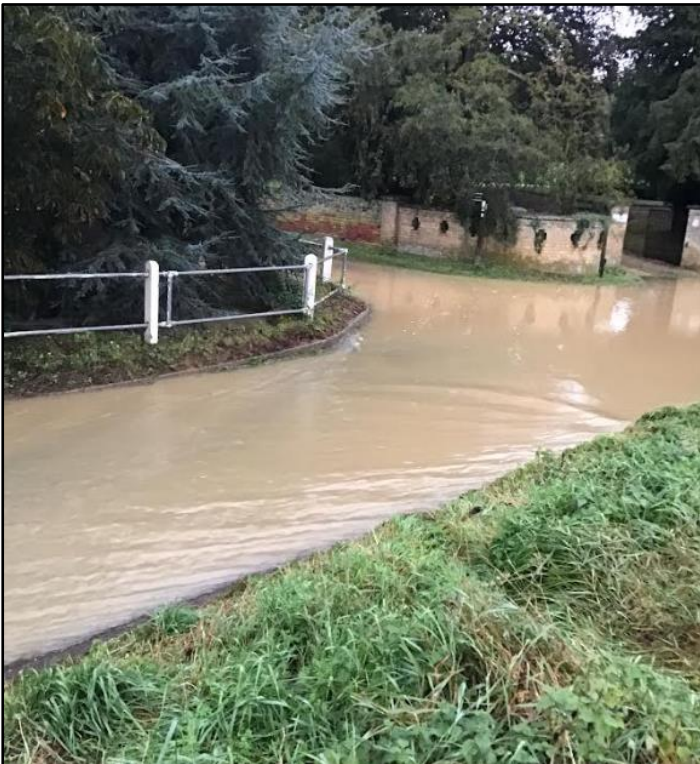
Image 3. Parham highway flooding
